# Restoring the Choctawhatchee through targeted sediment reduction

Presented at the Florida Stormwater Association Conference

This presentation is based on JMT's work for Florida DEP under Deepwater Horizon restoration funding in Florida's panhandle.

**Project objectives:** Reduce the sediment contribution to waterways from unpaved road-stream crossings to improve water quality and protected species habitat, especially Gulf Sturgeon

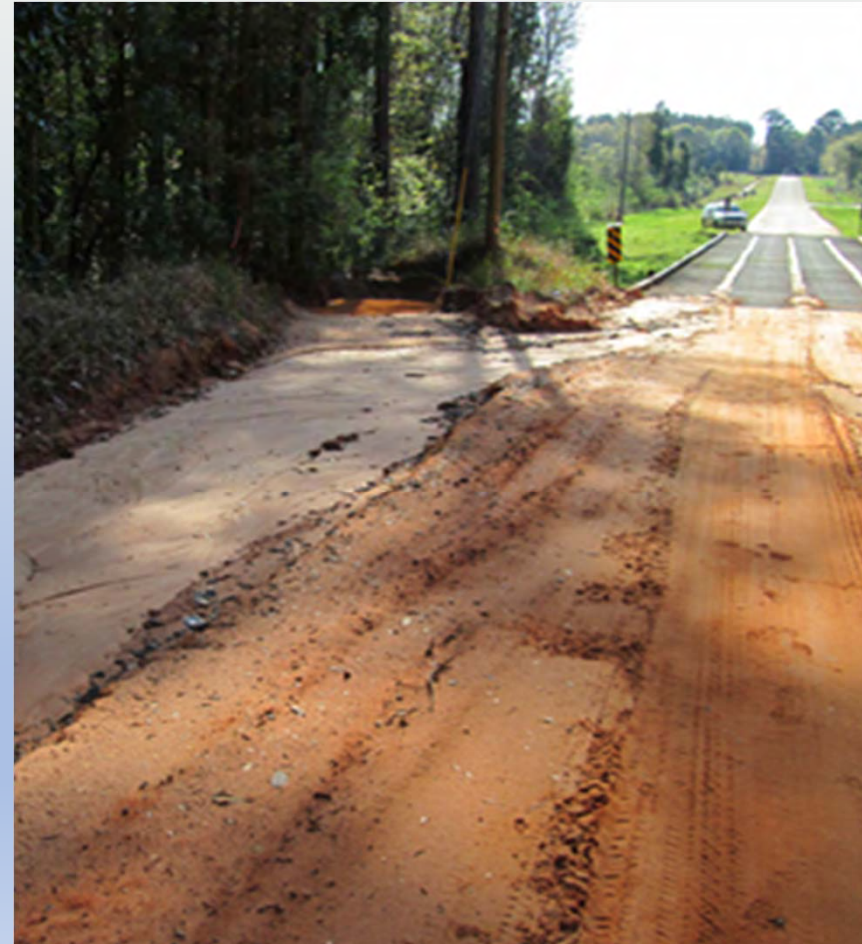
- Unpaved road beds erode directly into streams
- Roadside drainage ditches convey sediment into streams

Steele Road over Penny Creek in Okaloosa County, Florida

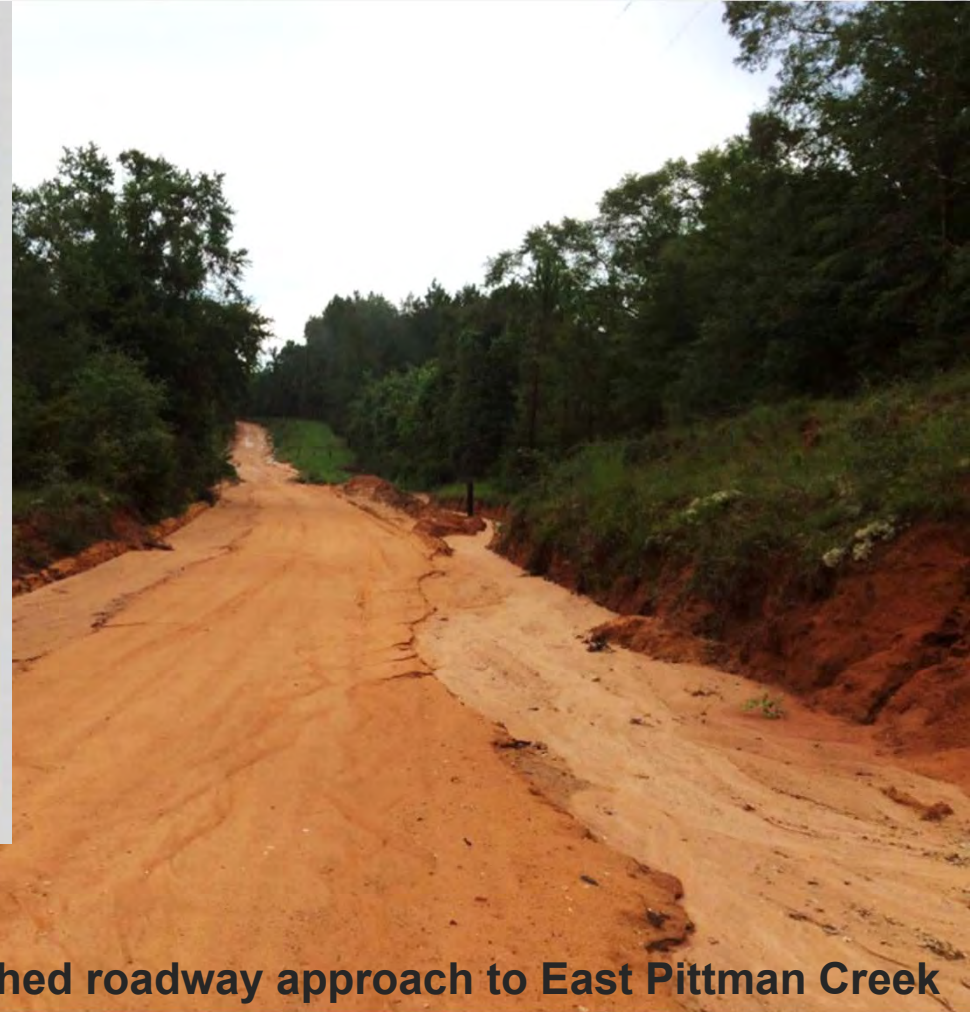
## Degraded Road Profile

Severely entrenched roadway approach to East Pittman Creek

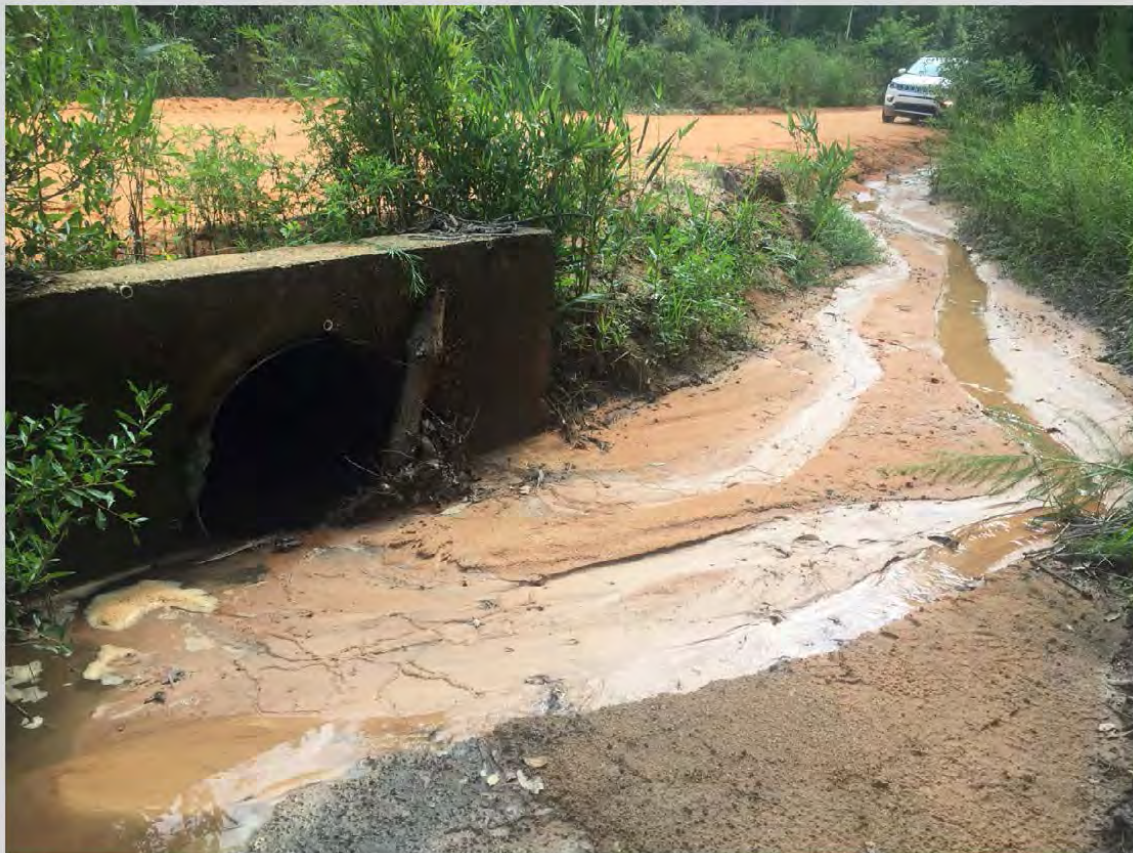
*Unnamed Tributary, Roland Road*

**Unimpeded flow from road to stream**

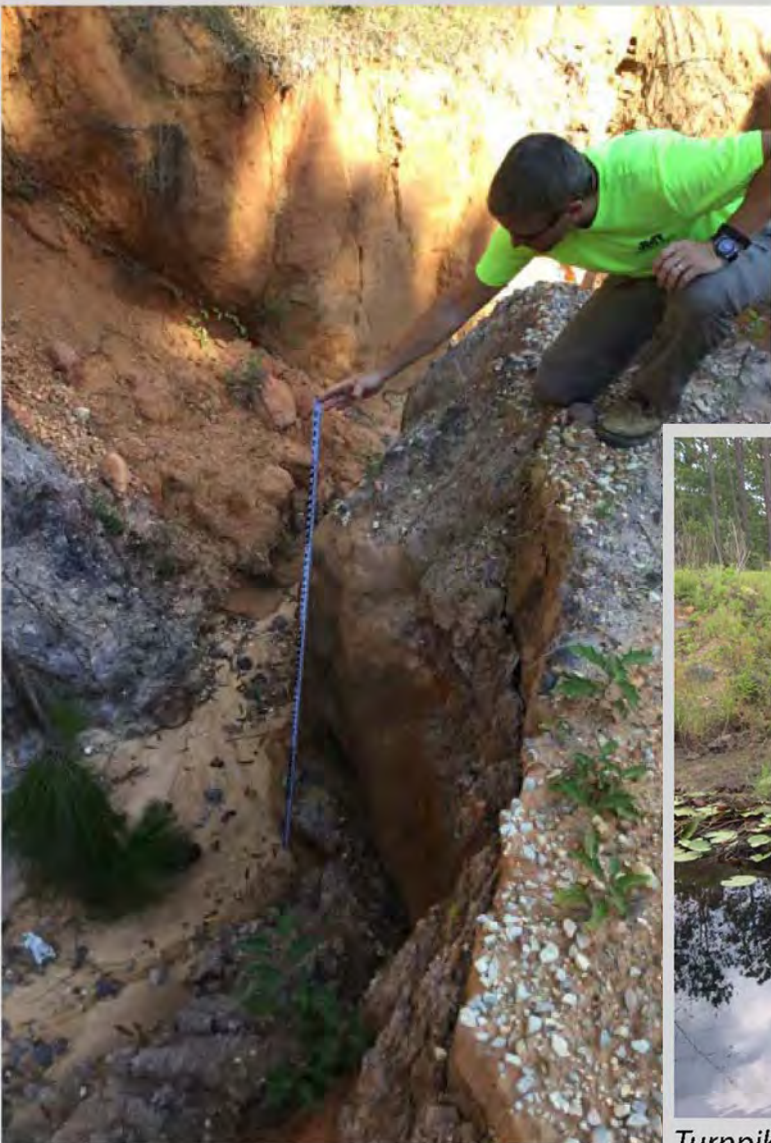
*Unnamed Tributary, W V Armstrong Road*

**Degraded roadside ditches**

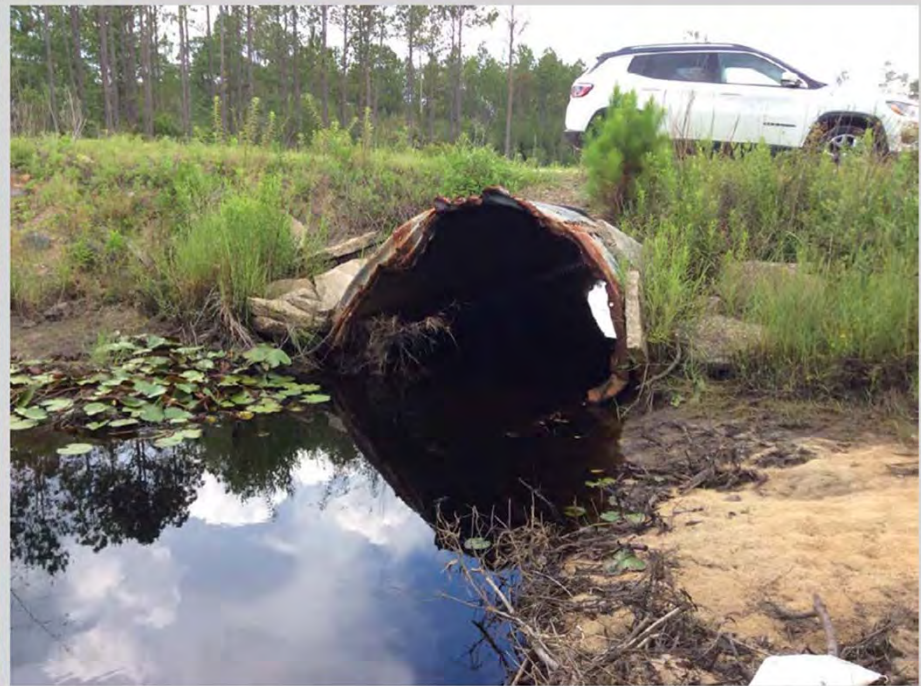
*Turnpike Branch, Joe Dugger Road*

**Culvert obstruction**

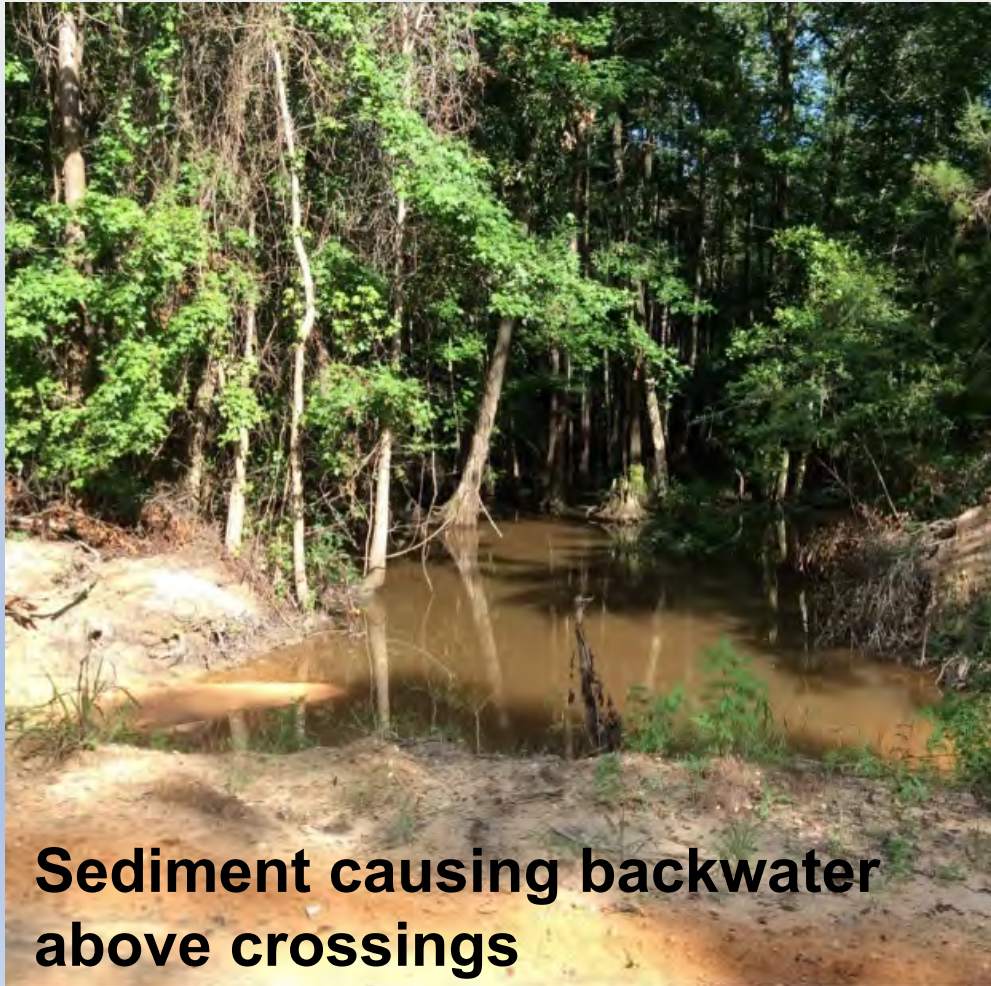
Sediment runoff at unpaved-road crossings: upstream and downstream views

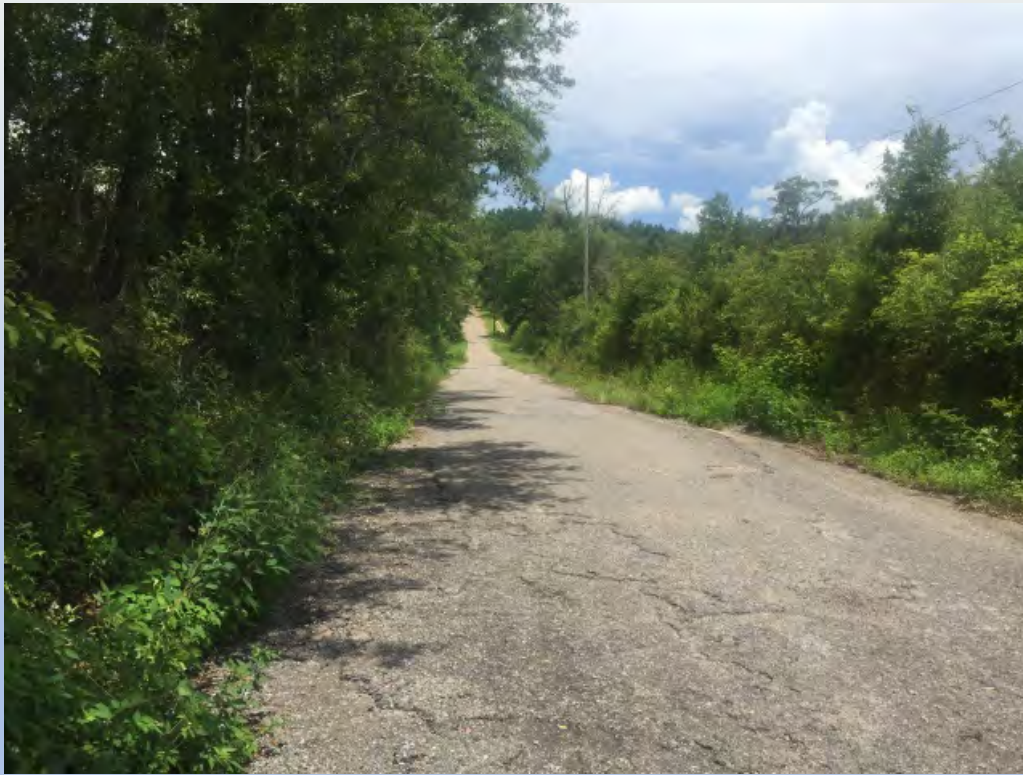
**Paved, steep right approach of Firetower Road crossing of Reedy Creek, Washington County, FL (JMT Photo)**

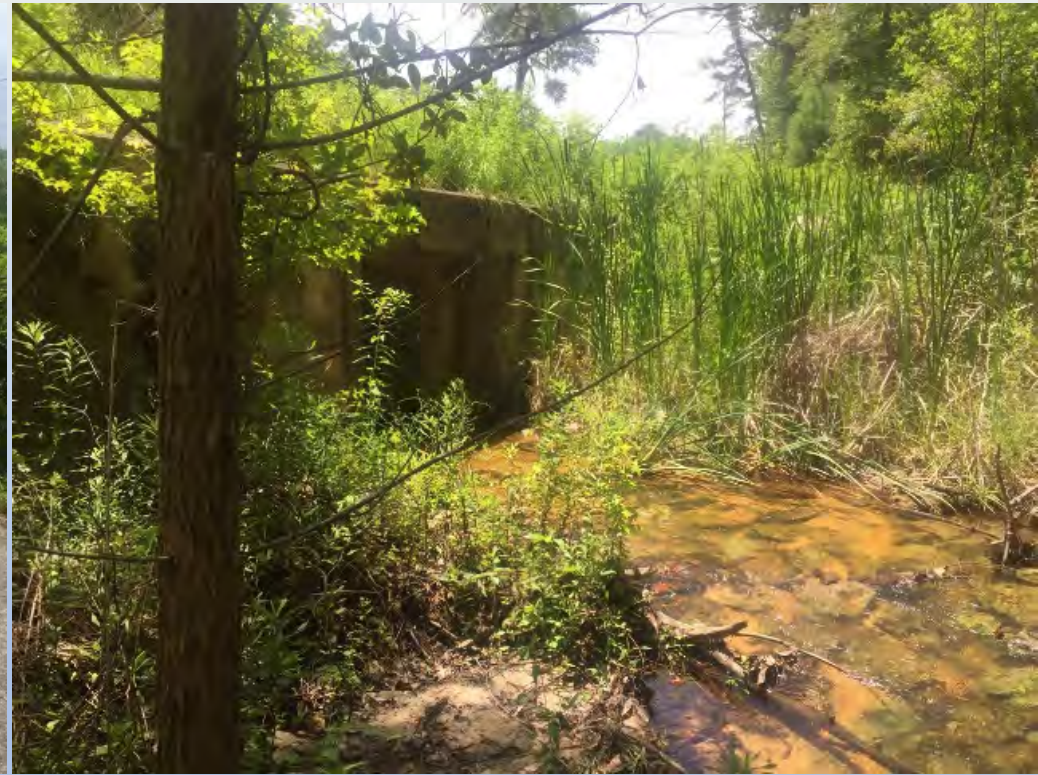
**Clear water and stable crossing at Firetower Road and Reedy Creek, Washington County, FL (JMT Photo)**

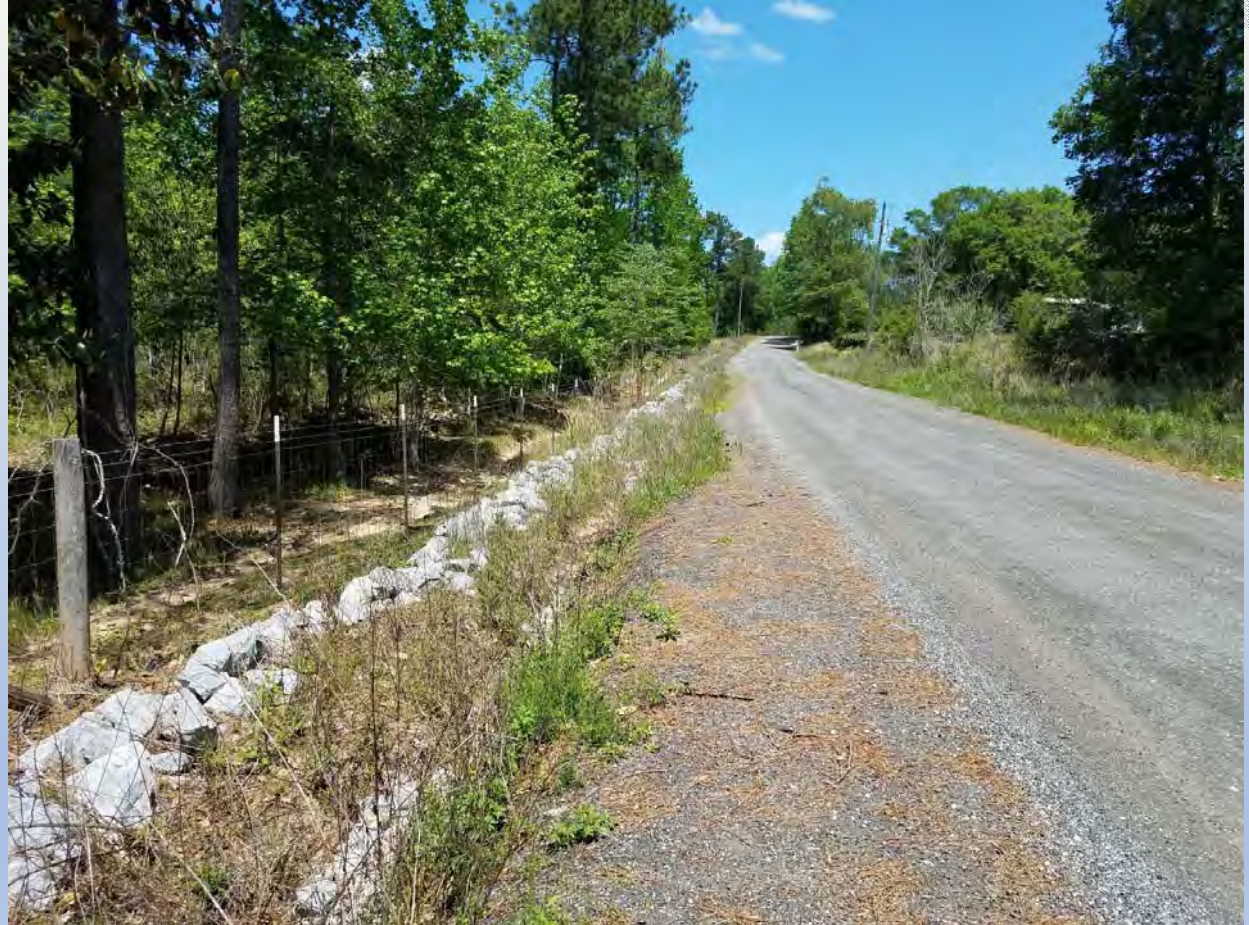
Roadway aggregate and riprap ditch in Walton County, FL

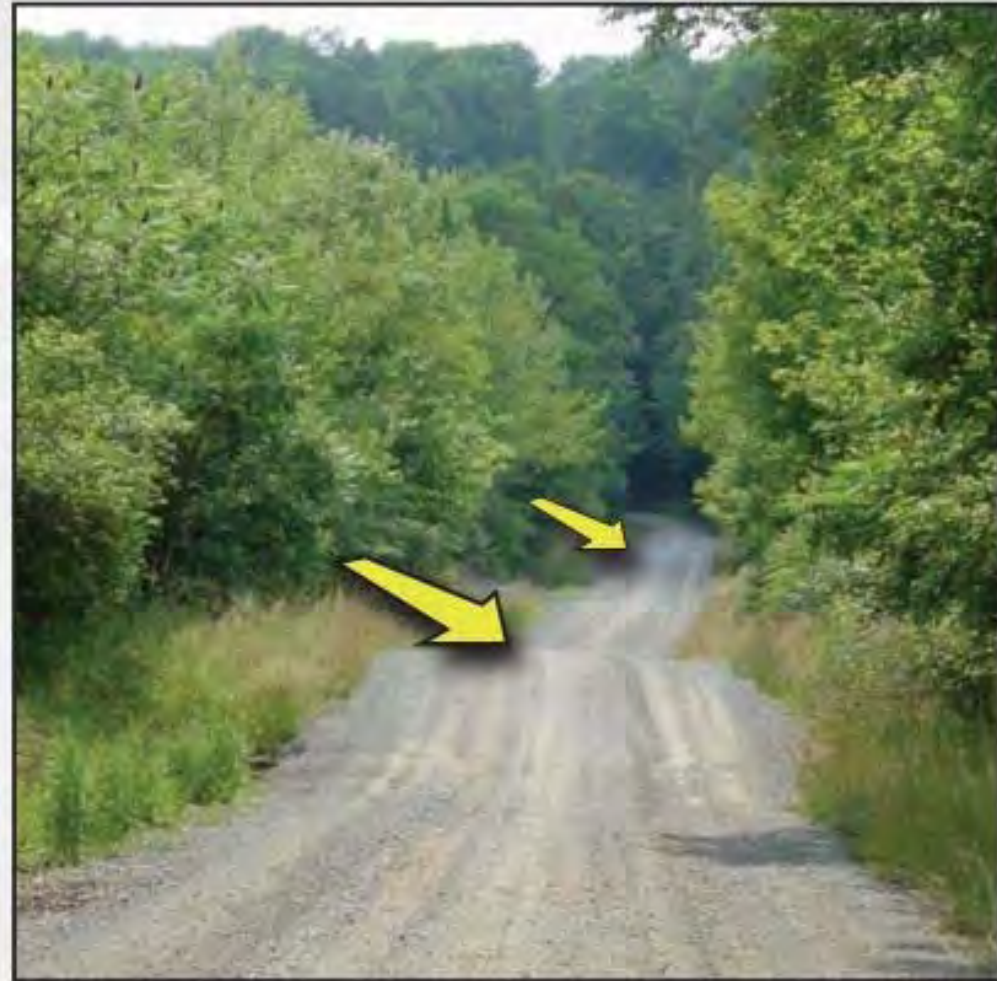
*Figure 3.7—The two grade breaks pictured here prevent water from flowing down the road, even if the road's crown were to be lost.*

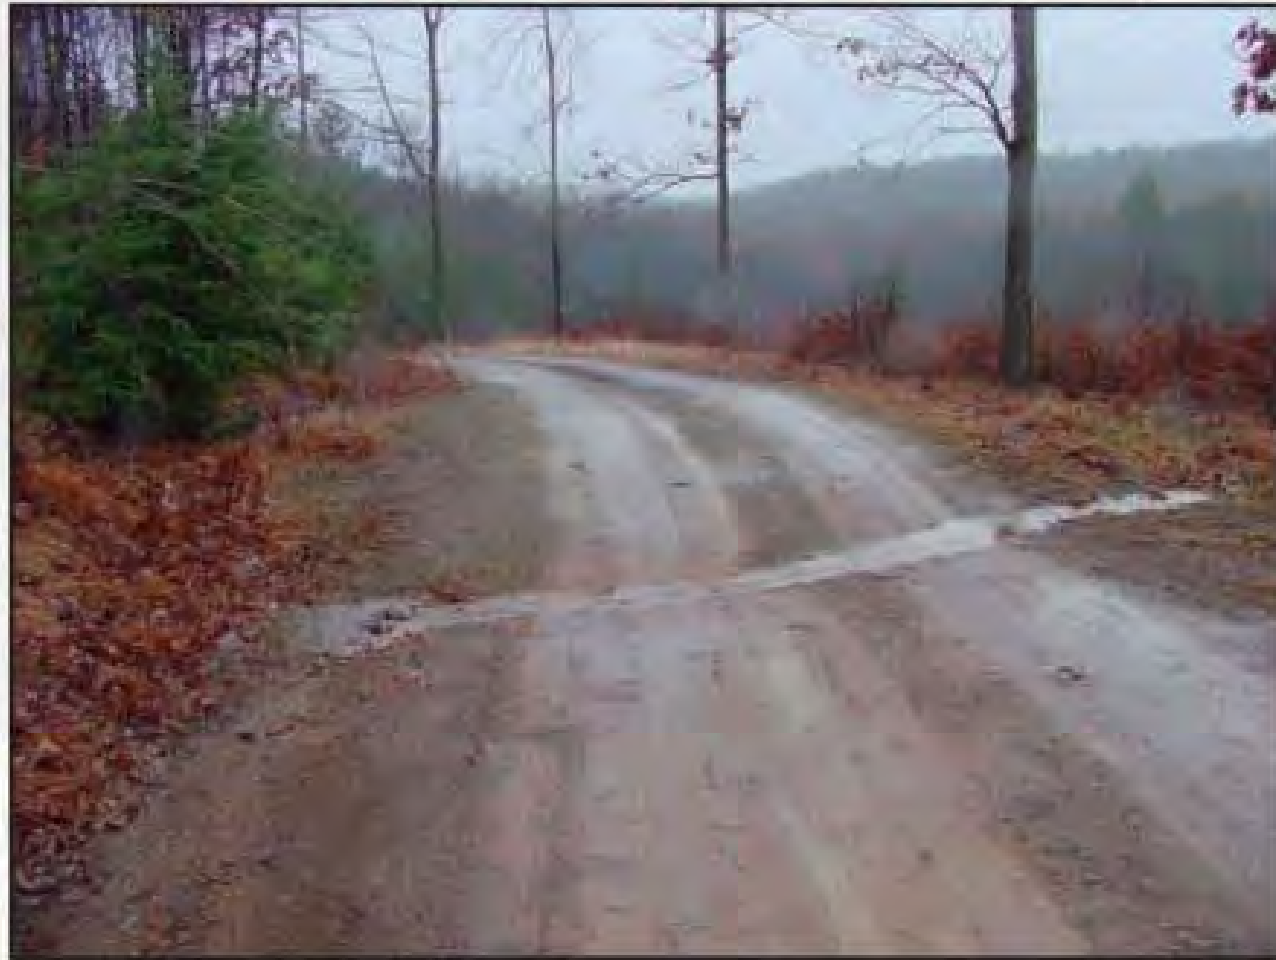
*Figure 3.10—The broad-based dip pictured here conveys water from the road surface and upslope ditch into a vegetative filter area on the right.*

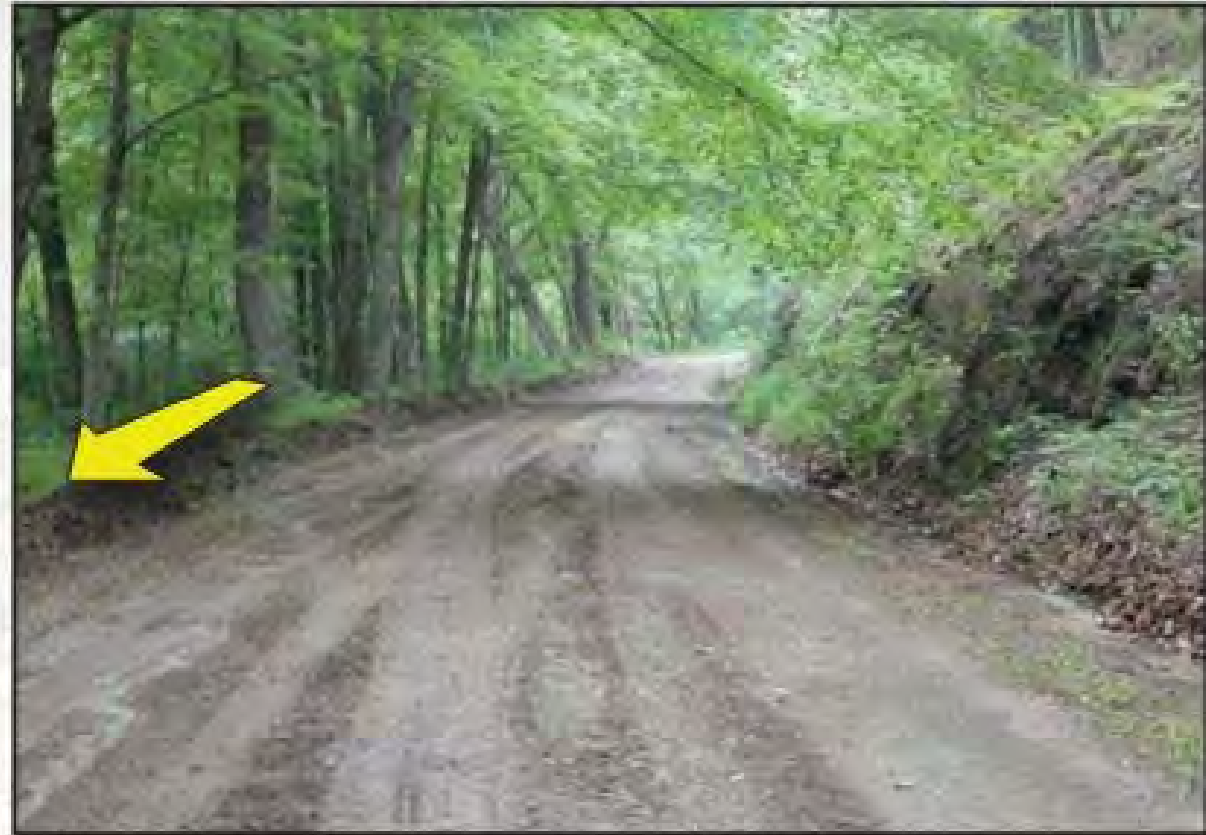
*Figure 4.15—The berm was created by recent grading. Removing the berm and crowning the road allows sheet flow into the vegetation to the left.*

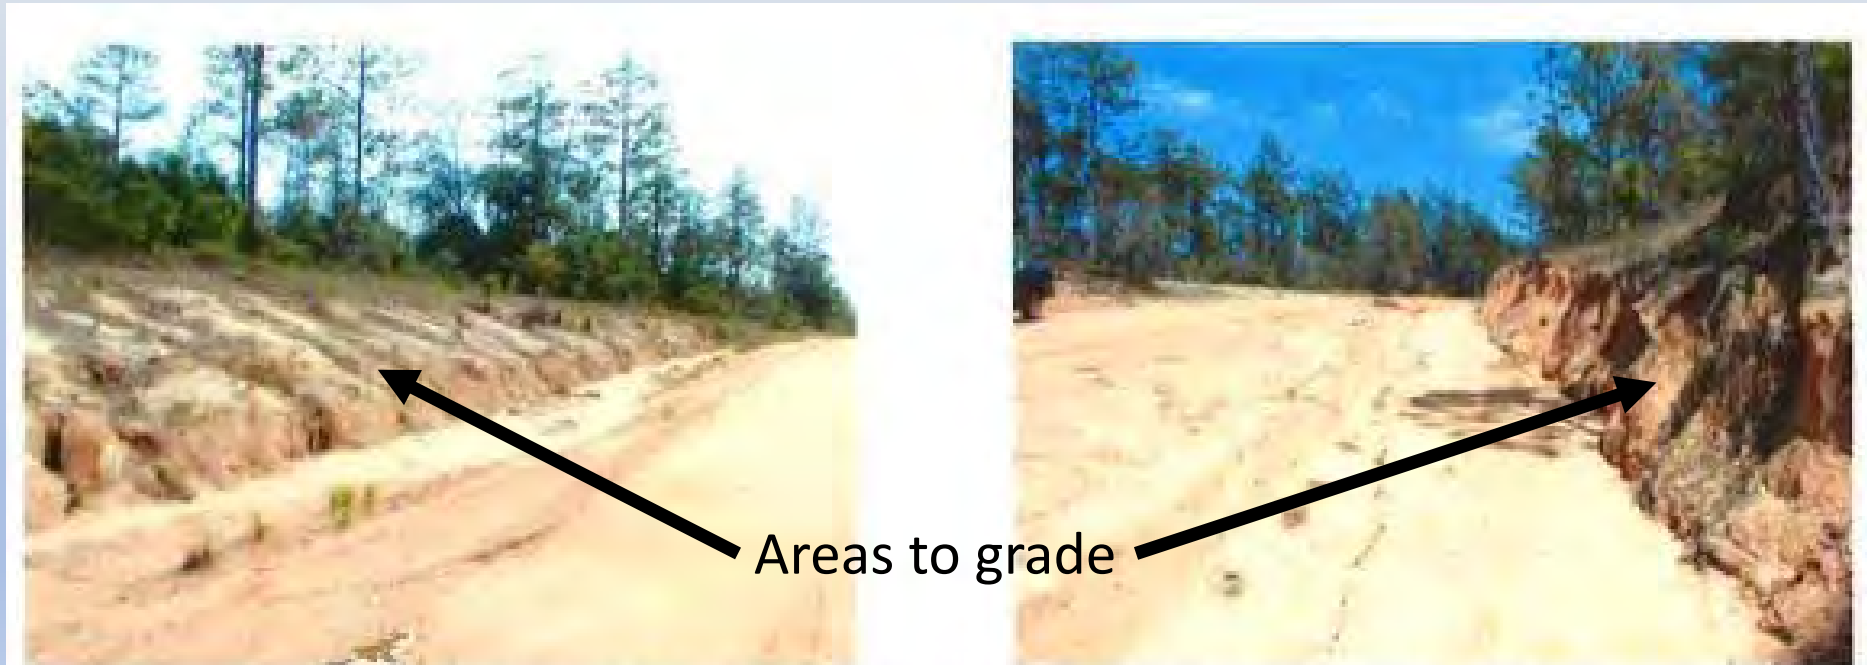
**Figure 2-1. Severely Eroded Unstable Roadside Slopes** (Photos by Mike Rainer)

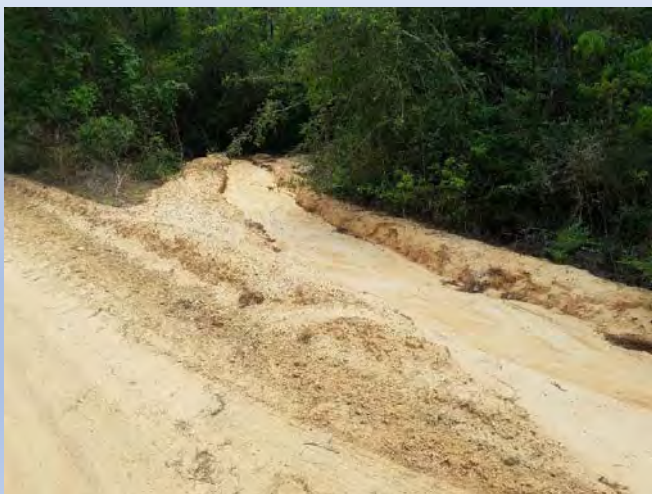
Turnouts are not always a panacea (JMT, 2018)

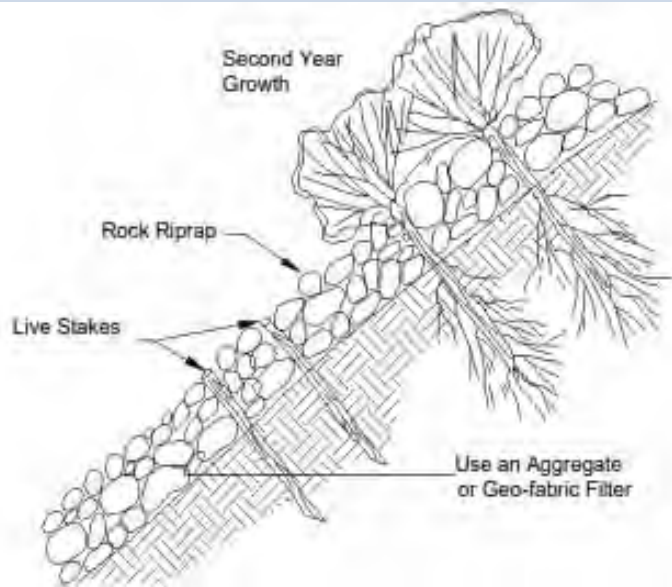
Figure 5-13. Vegetated Riprap Revetment

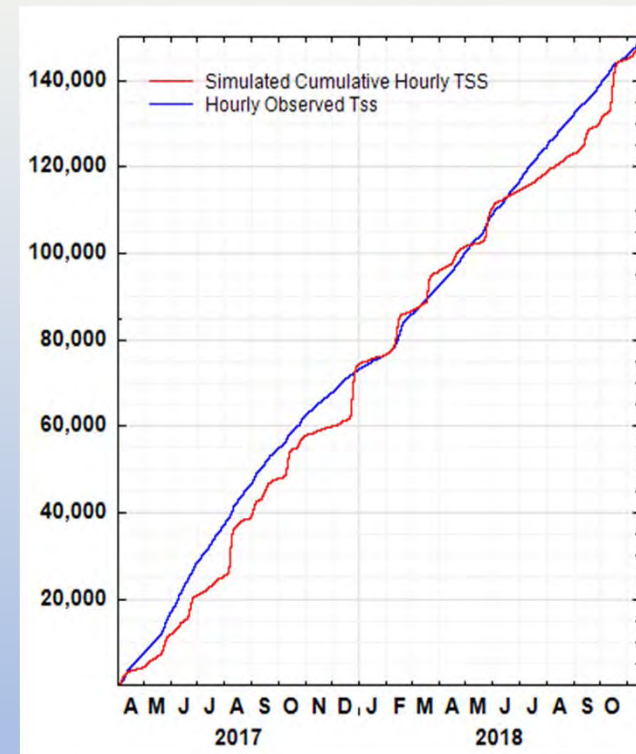
**Sediment concentrations were calibrated to TSS and turbidity measurements**

\* Bedload is unknown. The values of "cumulative hourly TSS concentration" are not meaningful, but they are a useful metric for model calibration

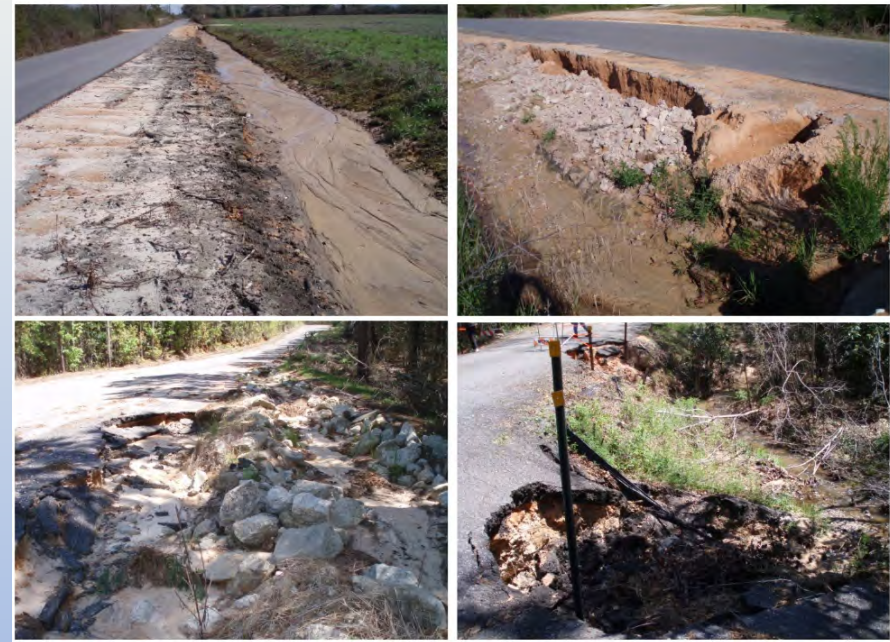
Paving approaches must also consider drainage or risk failure (SAIC, 2013)
