FSA Winter Conference

Exposing Sewage Pollution with Microbial Source Tracking

Sandy Reller
Public Works Operations
City of Titusville

Kevin Tyre, MS
Water Resources Scientist
Geosyntec Consultants

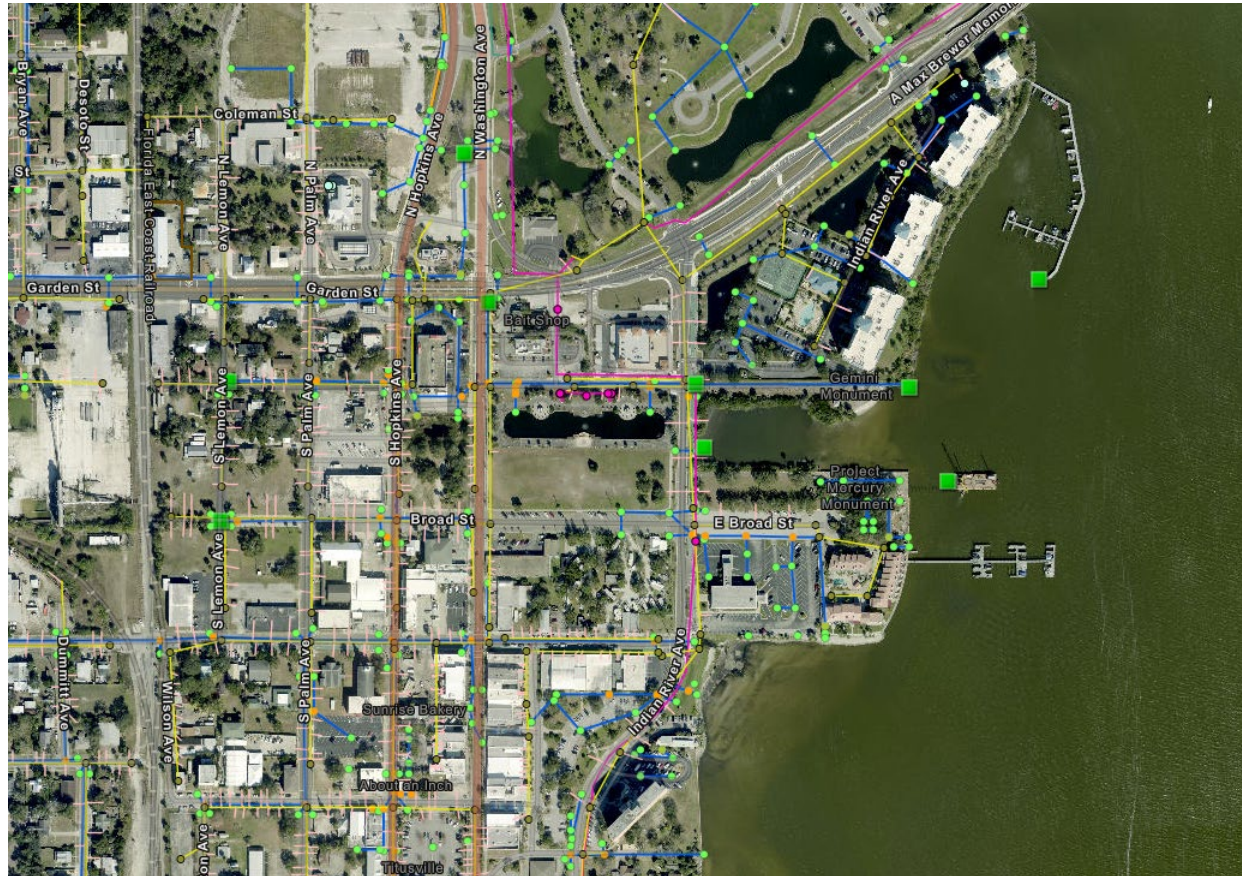
Relevant Data

- Stormwater Pipes
- Sanitary Pipes – Gravity
- Sanitary Pipes – Pressurized
- Sanitary Laterals
- Stormwater Inlets
- Stormwater Manholes
- Sanitary Manholes

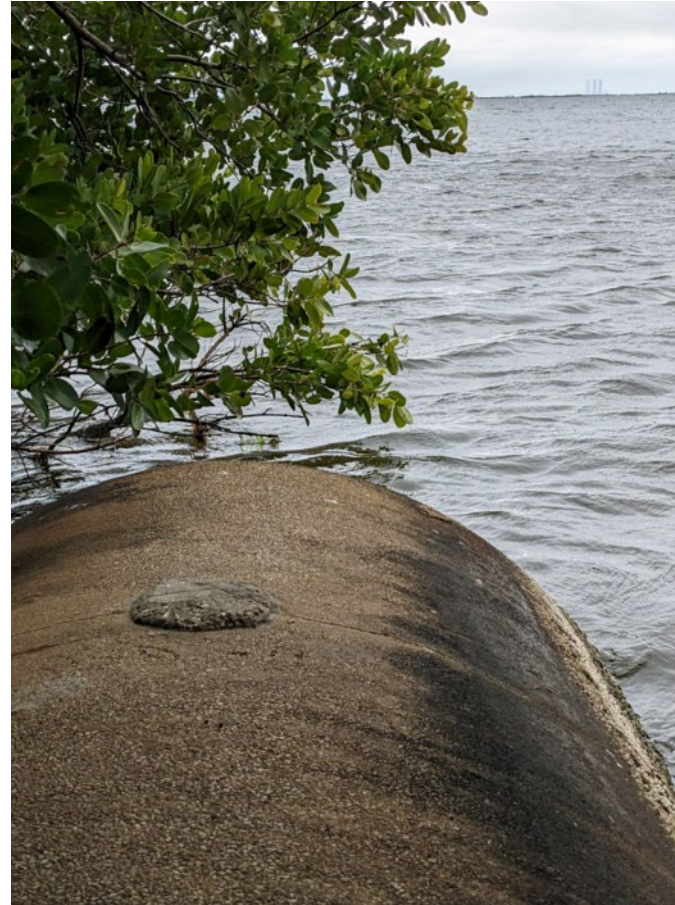
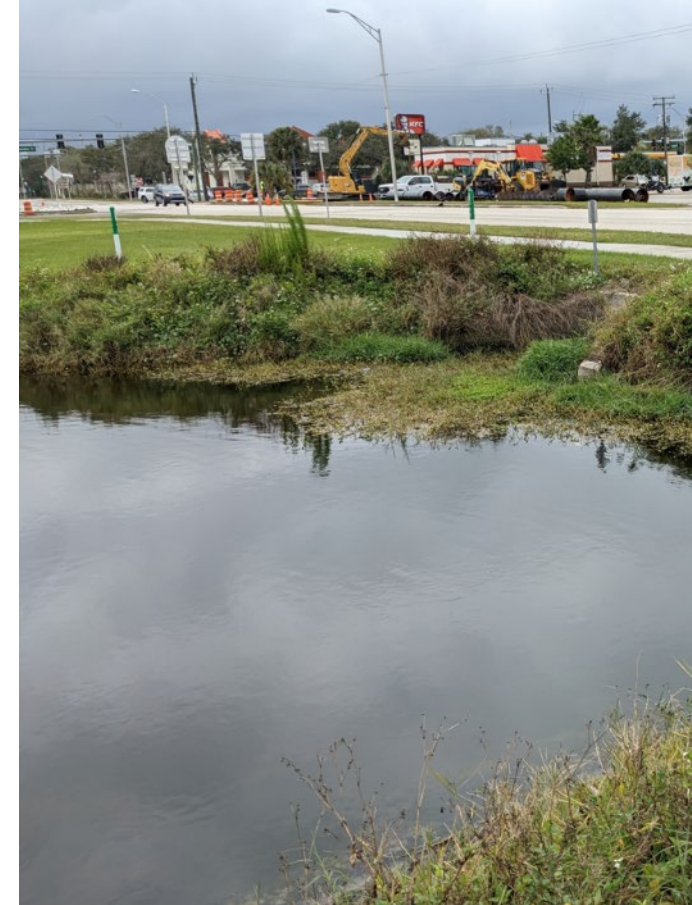
Field Reconnaissance

- Stormwater Outfall
- Upstream Hydraulic Connectivity

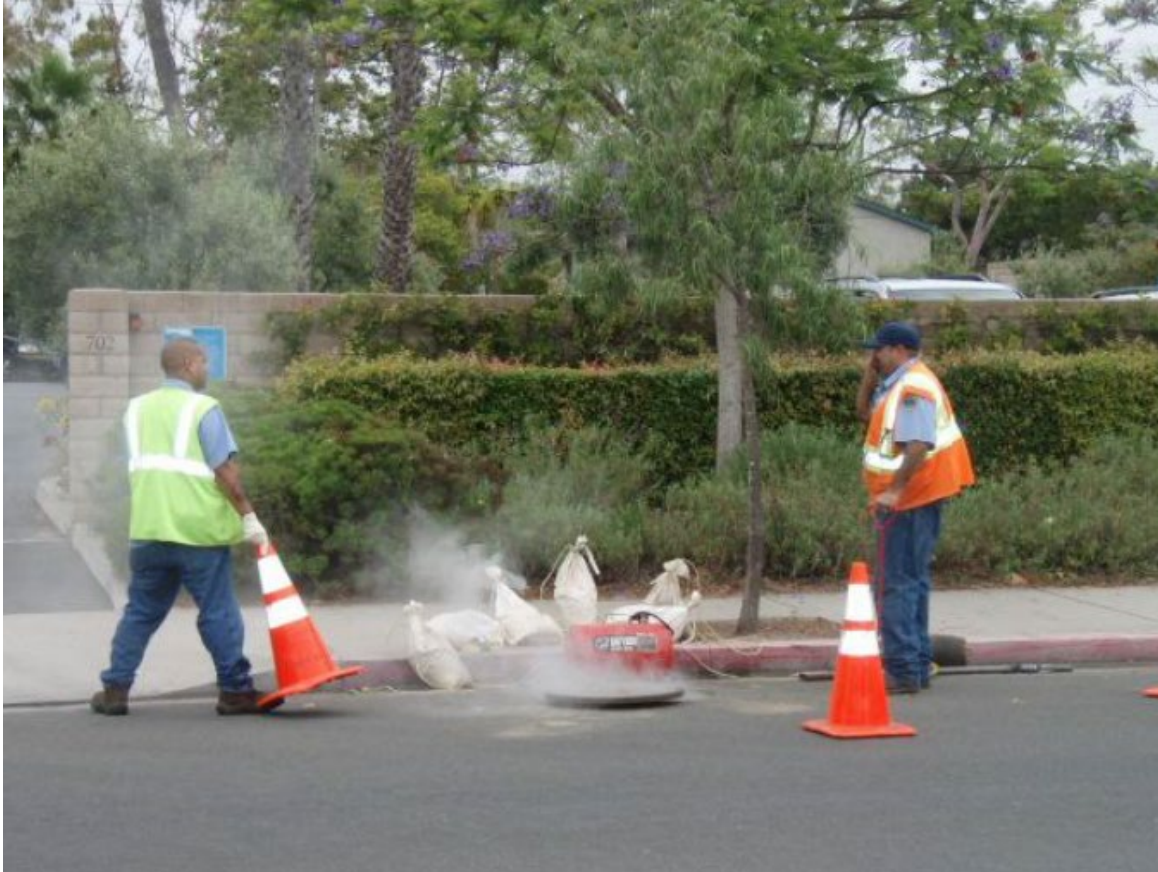
Smoke Testing

- Smoke escapes through cracks in pipes and is visually detected
- Detects leaks **above** the water line

Dye Testing

- Bright dye escapes through cracks in pipes and is detected visually or with sensor.
- Detects leaks **below** the water line

Visual Inspection (CCTV)

- Uses a remote camera to see inside pipes
- Visually detect large cracks and holes

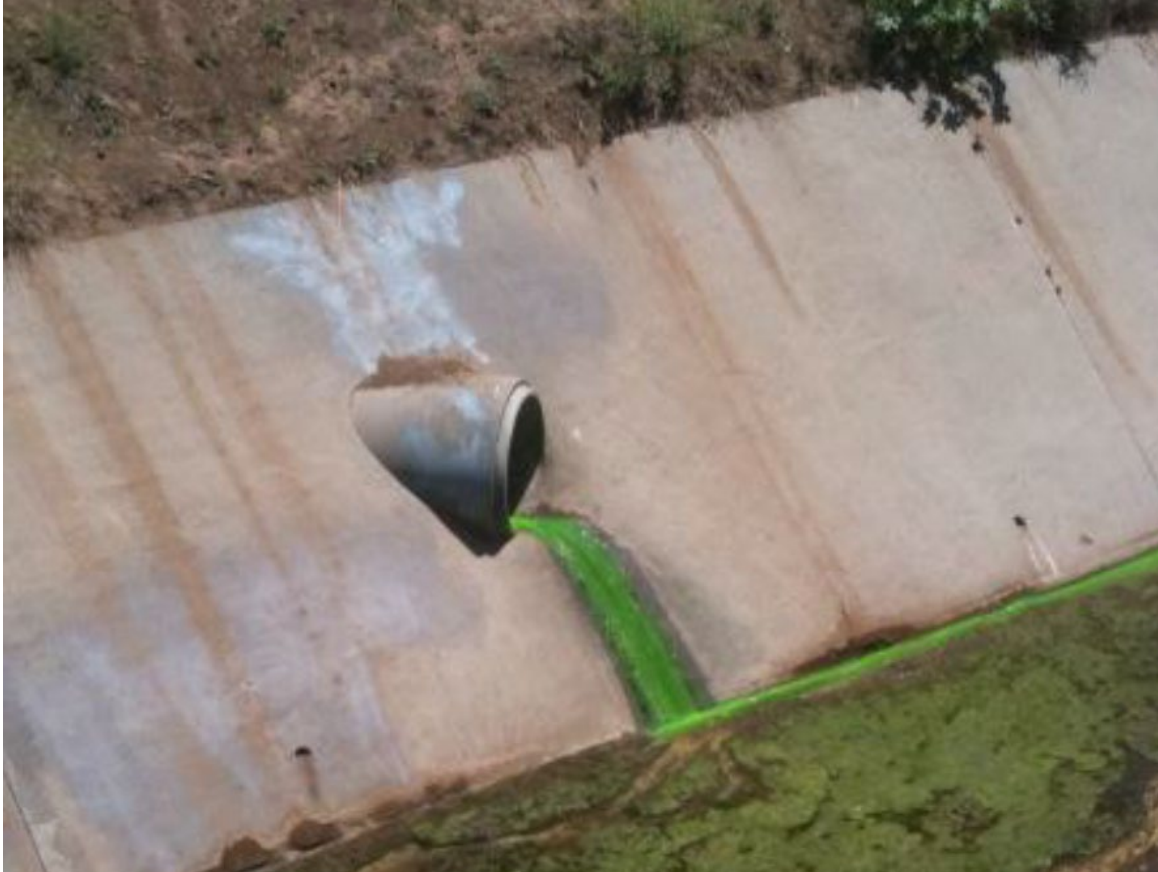
Smoke Testing

- Smoke escapes through cracks in pipes and is visually detected
- Detects leaks **above** the water line

Dye Testing

- Bright dye escapes through cracks in pipes and is detected visually or with sensor.
- Detects leaks **below** the water line

Visual Inspection (CCTV)

- Uses a remote camera to see inside pipes
- Visually detect large cracks and holes

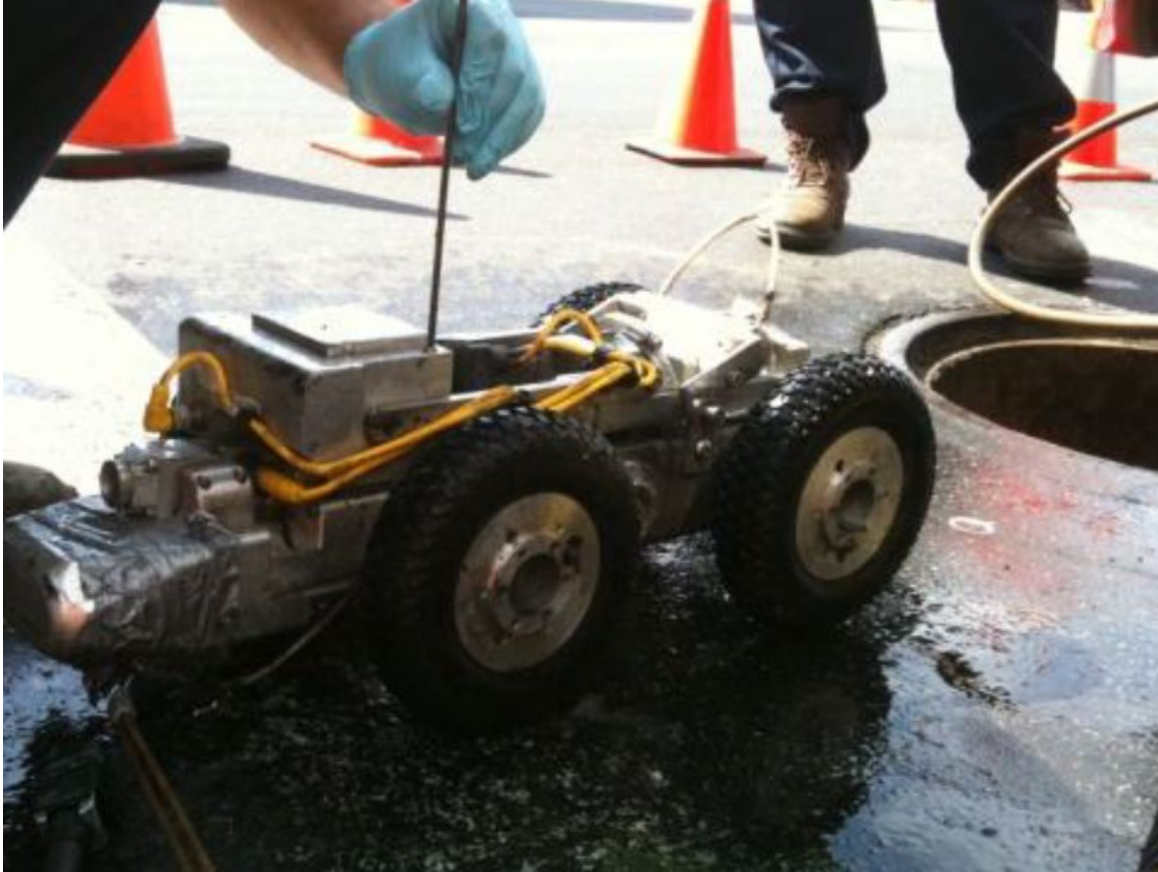
Smoke Testing

- Smoke escapes through cracks in pipes and is visually detected
- Detects leaks **above** the water line

Dye Testing

- Bright dye escapes through cracks in pipes and is detected visually or with sensor.
- Detects leaks **below** the water line

- Uses a remote camera to see inside pipes
- Visually detect large cracks and holes
