# COASTAL RESILIENCE IN ACTION

## A Blueprint for Smarter Stormwater Management

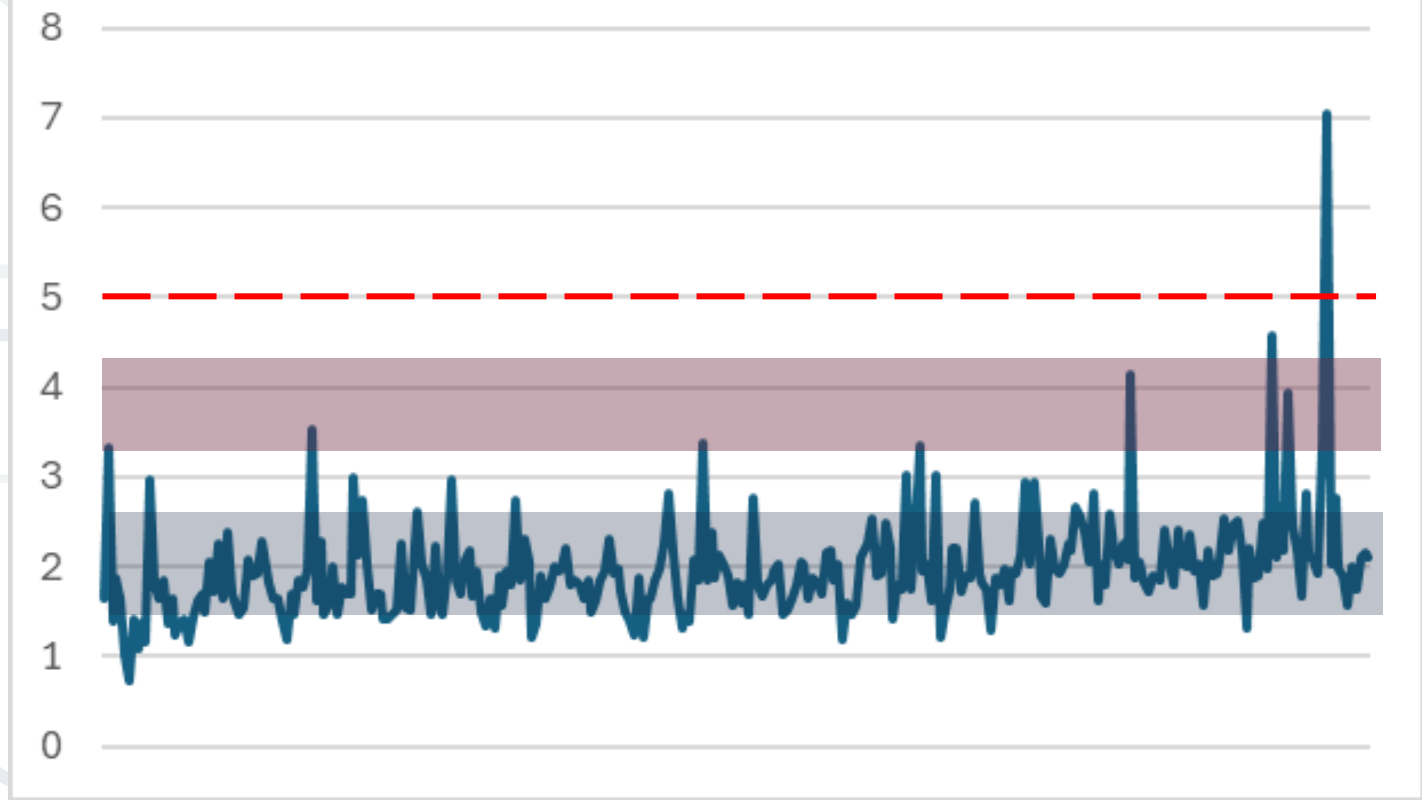
Monthly Maximum Water Levels  
(2000-2025, NAVD88)

# Historic Observed Tide Levels (Don CeSar Neighborhood)

## Legend

--- Future Seawall Elevation

Average Lot Elevation Range

Average Street Elevation Range

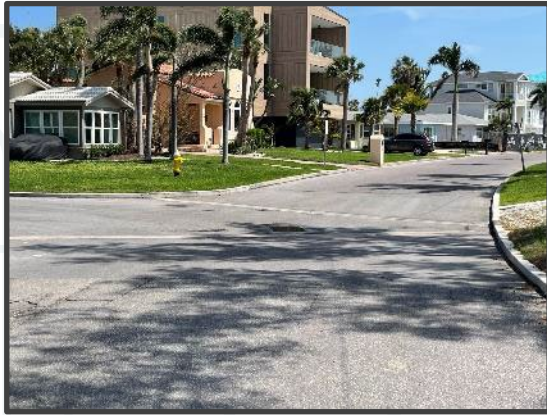
# Tide Elevation at 0.9 feet NAVD

Alhambra  
Street Elevation = 1.15 NAVD

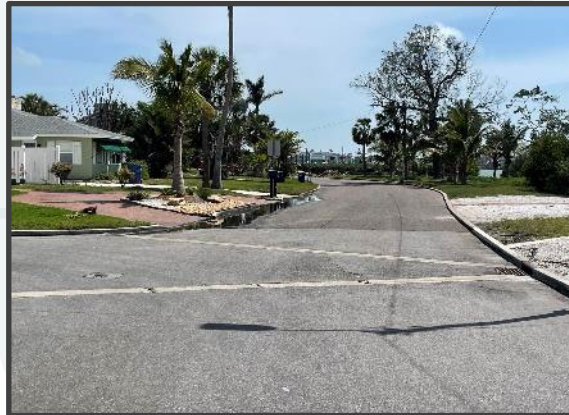
Alfonso  
Street Elevation = 1.13 NAVD

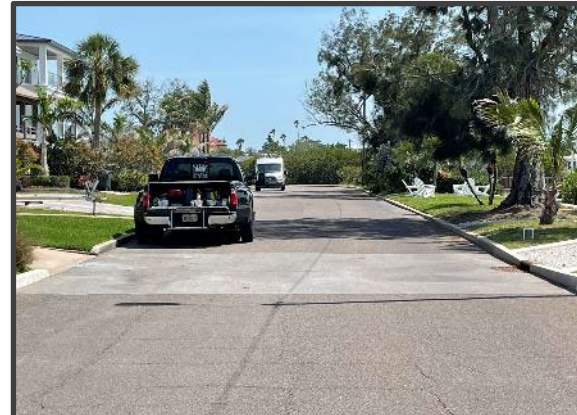
3107 Maritana  
Street Elevation = 1.80 NAVD

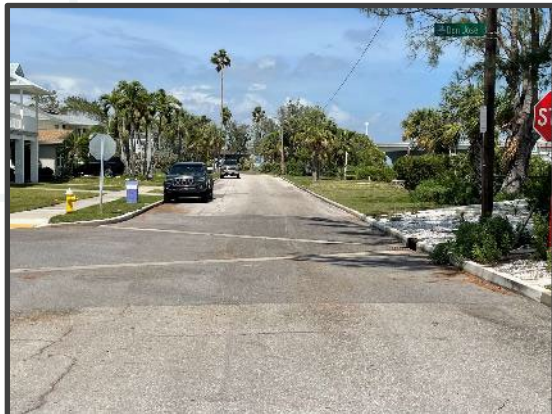
Don Jose  
Street Elevation = 1.30 NAVD

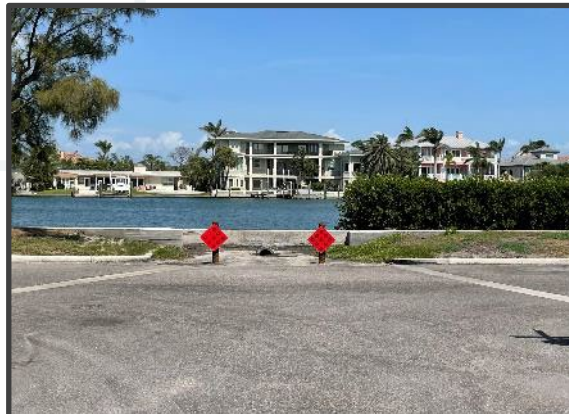
36<sup>th</sup> Ave  
Street Elevation = 1.30 NAVD

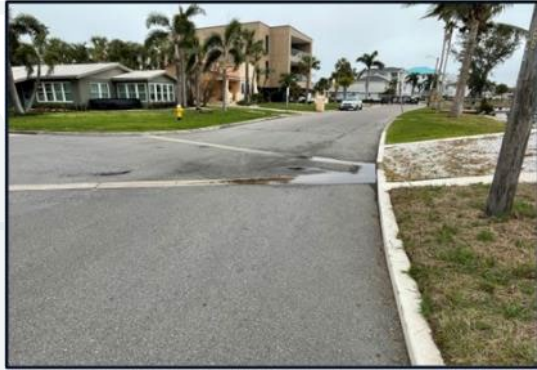
# Sunny Day Flooding – Tide Elevation at 1.5 feet NAVD

Alhambra  
Street Elevation = 1.15 NAVD

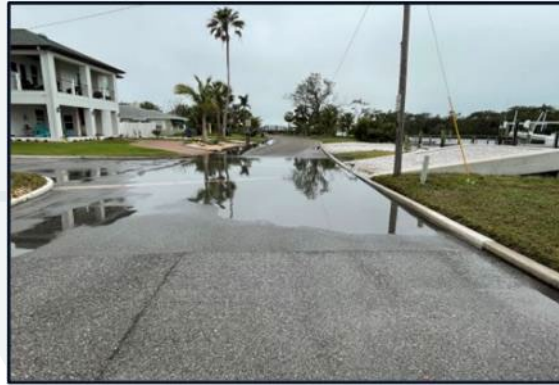
Alfonso  
Street Elevation = 1.13 NAVD

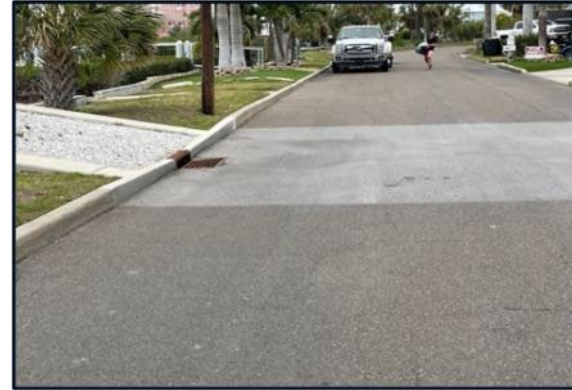
3107 Maritana  
Street Elevation = 1.80 NAVD

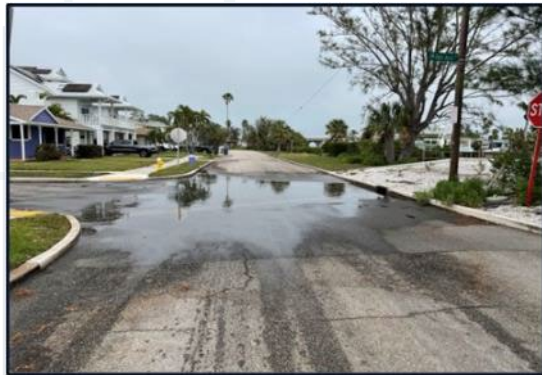
Don Jose  
Street Elevation = 1.30 NAVD

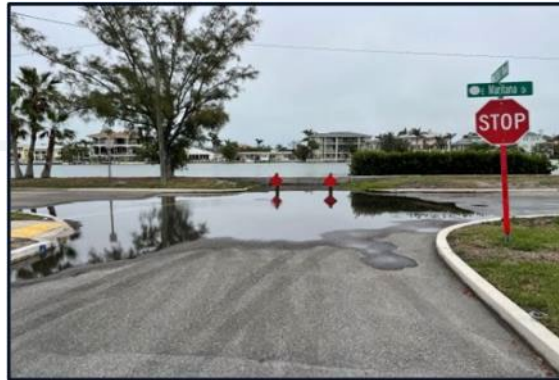
36<sup>th</sup> Ave  
Street Elevation = 1.30 NAVD

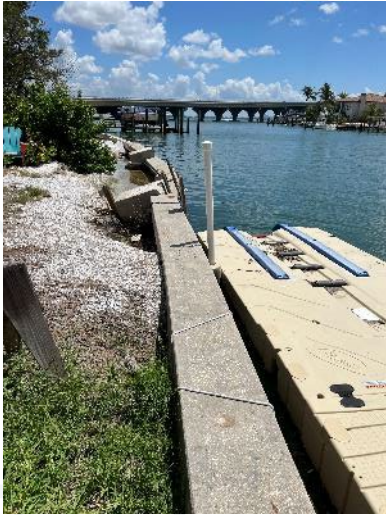
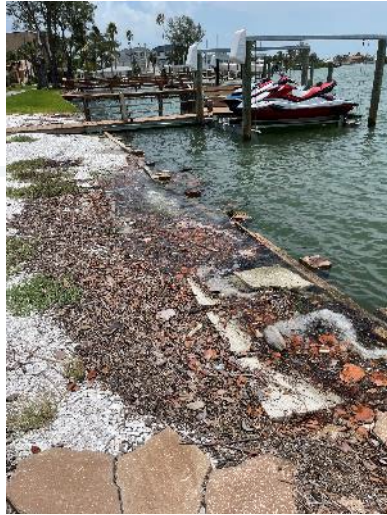
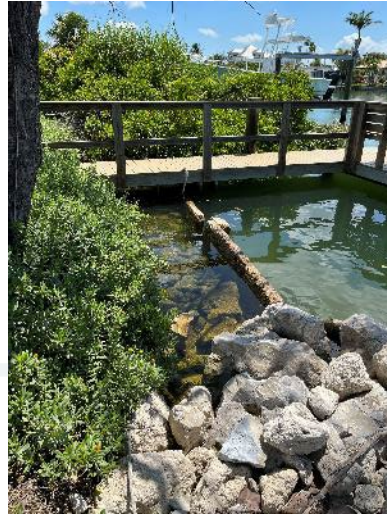
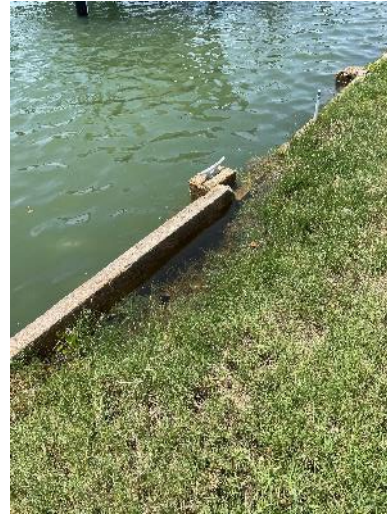
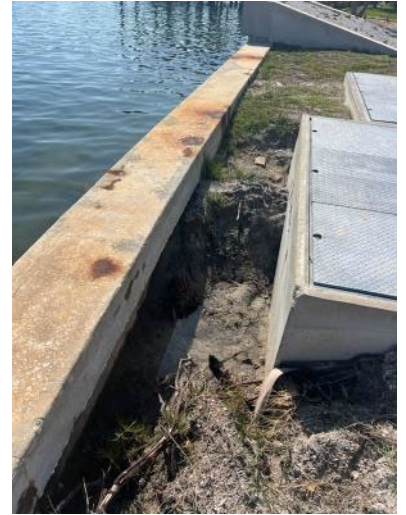
# Seawalls in Disrepair

## Disrepair Defined:

A shoreline protection structure that allows erosion, material transfer or unimpeded tidal flow through it to adjacent properties or public rights-of-way. It also includes structures originally permitted below required elevation that have deteriorated, resulting in water flowing over them to nearby properties or public areas.

Approx. 8,600 feet of seawall owned by City (10% of all seawalls in the City)

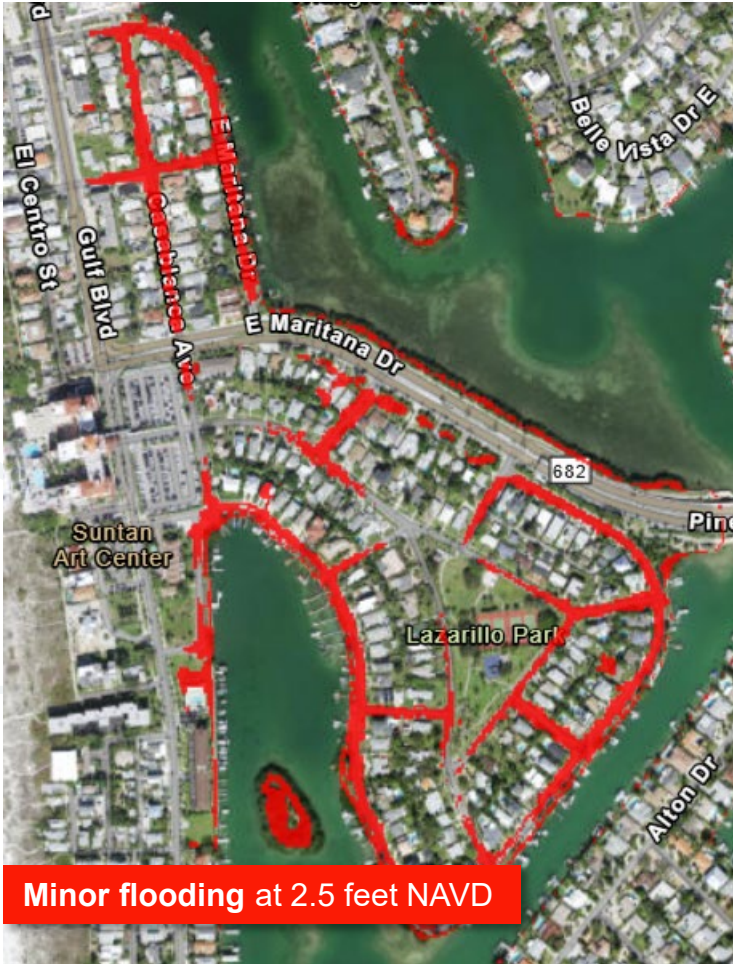
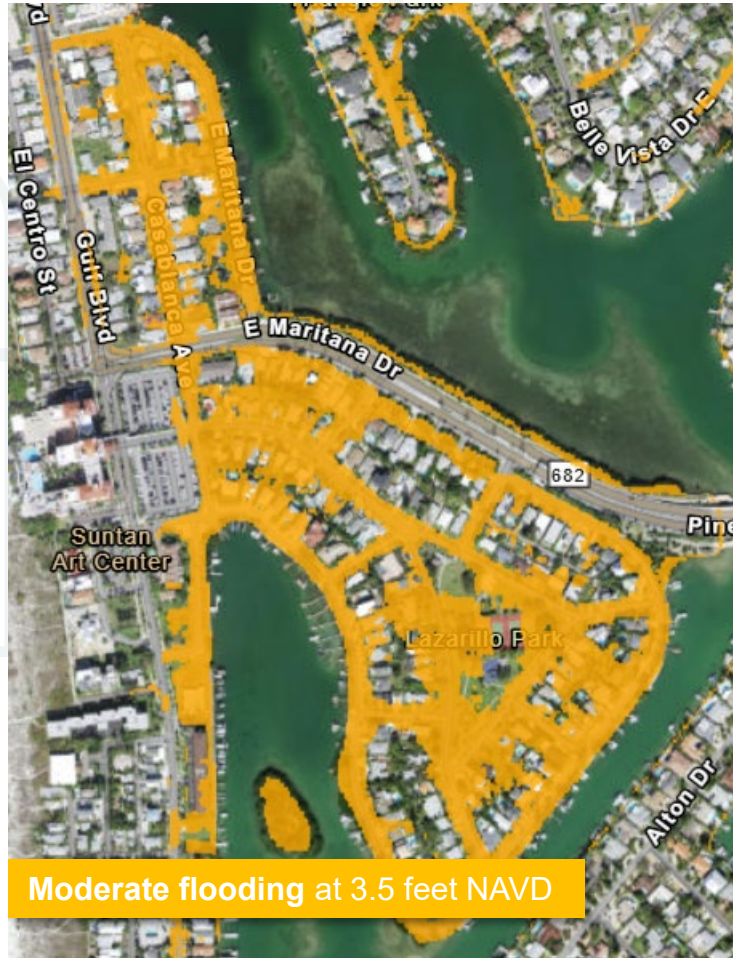
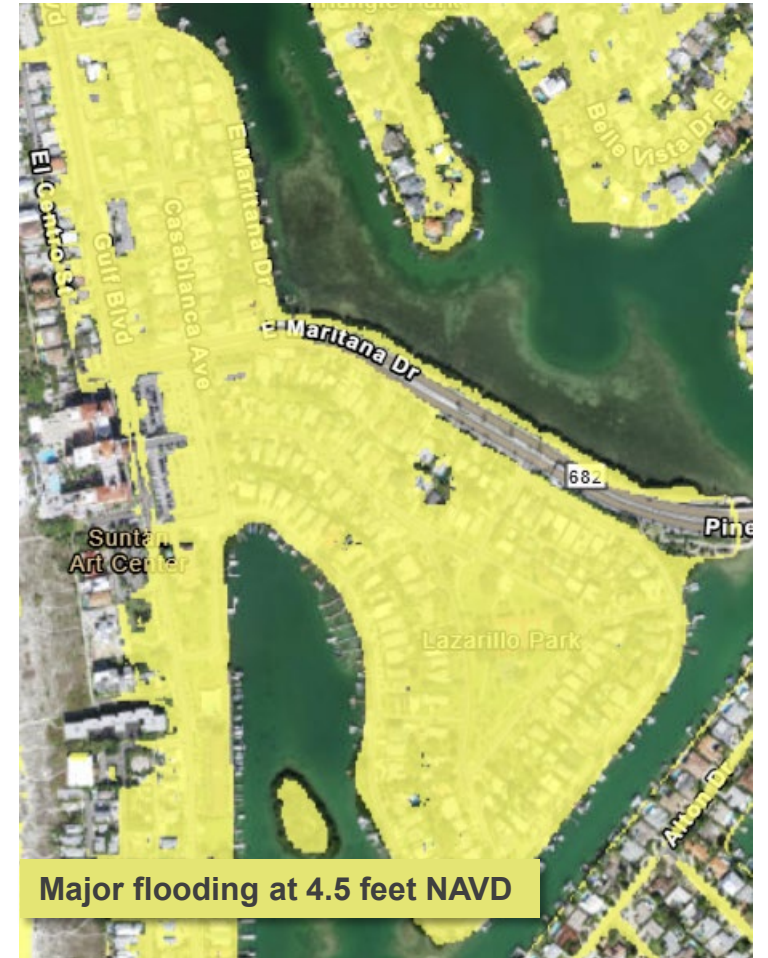
# ■ | Flooding Scenario in a local neighborhood

Sea Level Rise and Coastal Flooding Impacts (NOAA)

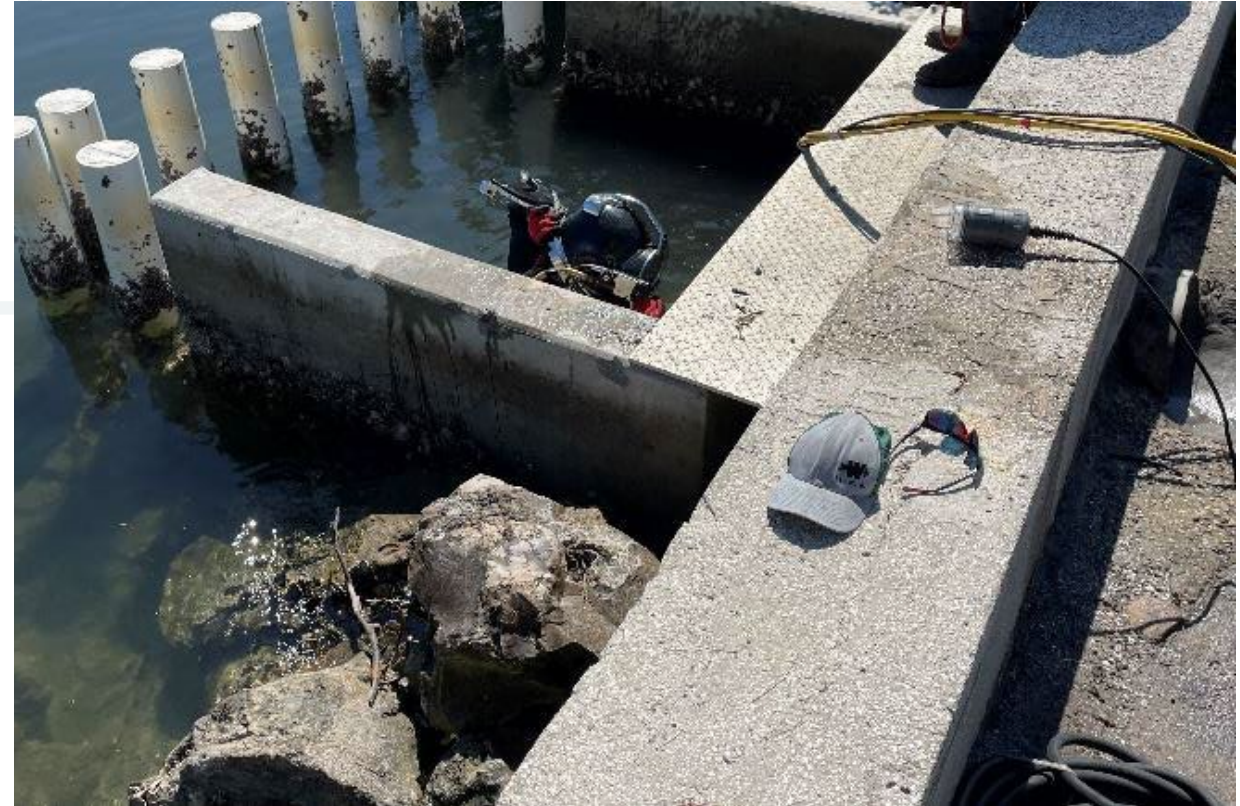
# Infrastructure Impacting Operations

## Maintenance

- Reduce need for commercial diving contractors
- Maintain in-house with crane truck

## Functionality

- Access/inspect all sides of check valve device
- Catch debris with baffle structure

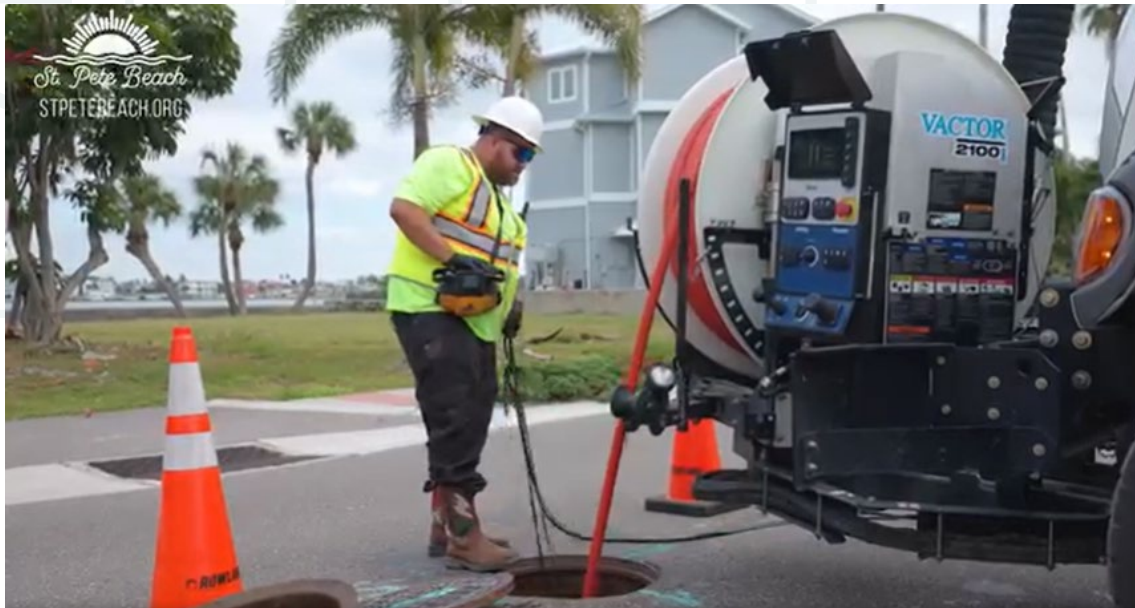
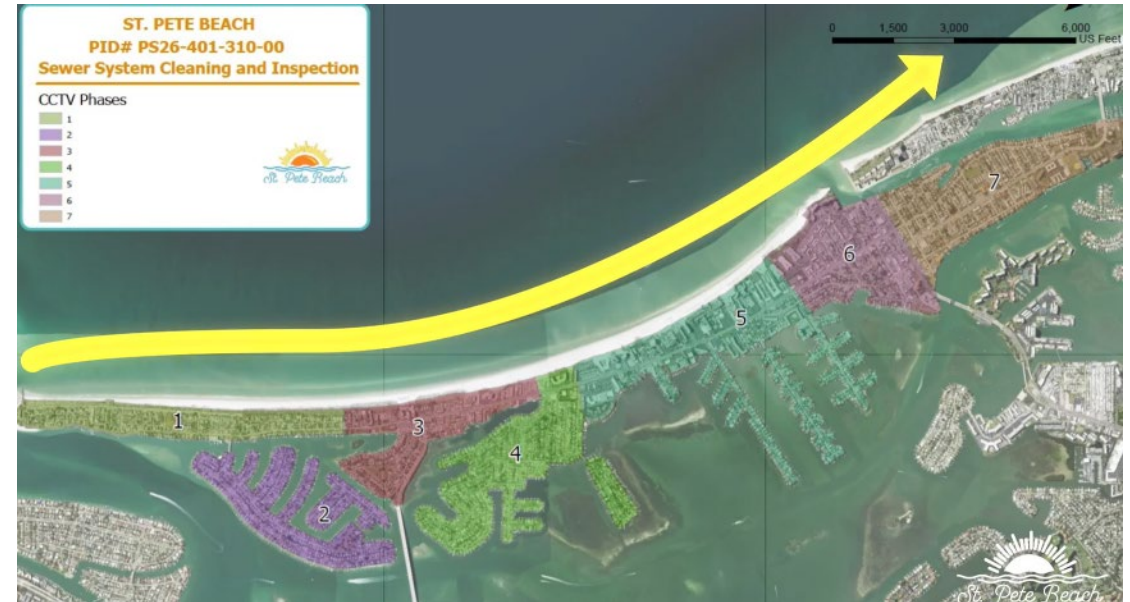
# Sewer System Maintenance Project

- Reduce Emergency Repairs
- Improve Maintenance
- Plan for Long Term Upgrades

- Pipe Cleaning: 27,925 LF complete / 90,975 LF total (~31% complete)
- CCTV: 16,193 LF complete / 90,975 LF total (~18% complete)
- Structure Inspections: 195 complete / 1,107 total (~18% complete)
- Projected Completion: August 2026 (est.)
- Key Issues:
  - Concrete inlet lid access
  - Diver-required outfall plugging
  - Extensive bypass/plugging

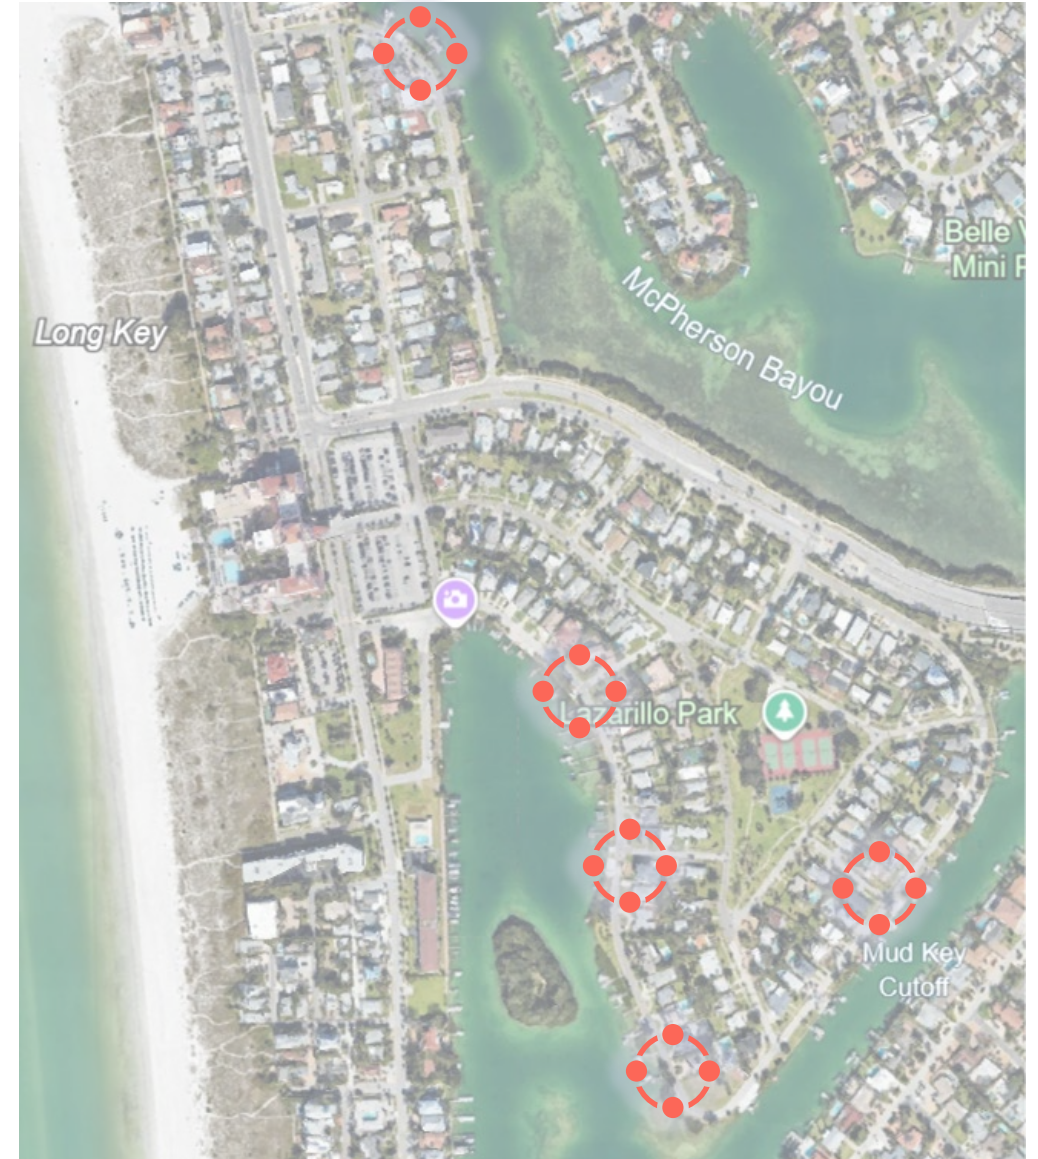
# Project Location – Don CeSar

- 37<sup>th</sup> Ave., Alhambra St., Alfonso St., 3107 W. Maritana Dr., and Don Jose St.

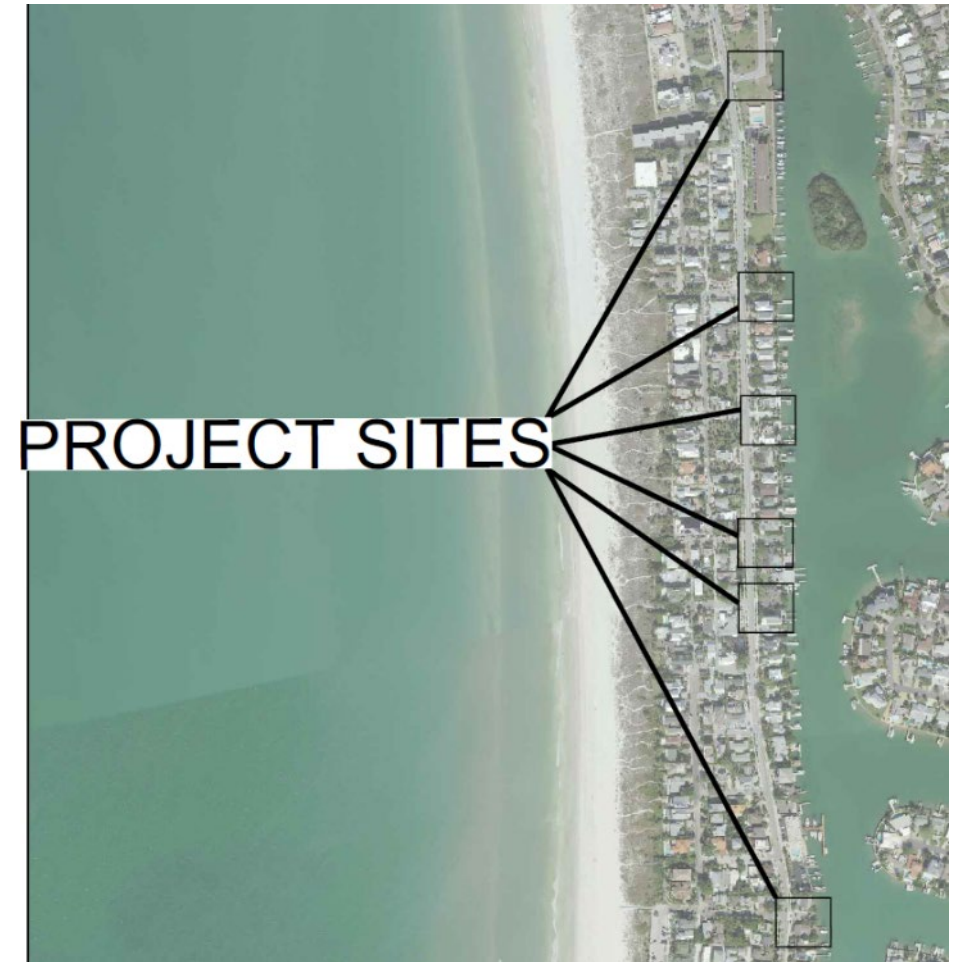
# Project Location – Pass-a-Grille

22<sup>nd</sup>, 27<sup>th</sup>, 28<sup>th</sup>, 29<sup>th</sup>, 30<sup>th</sup>, Cabrillo Aves.

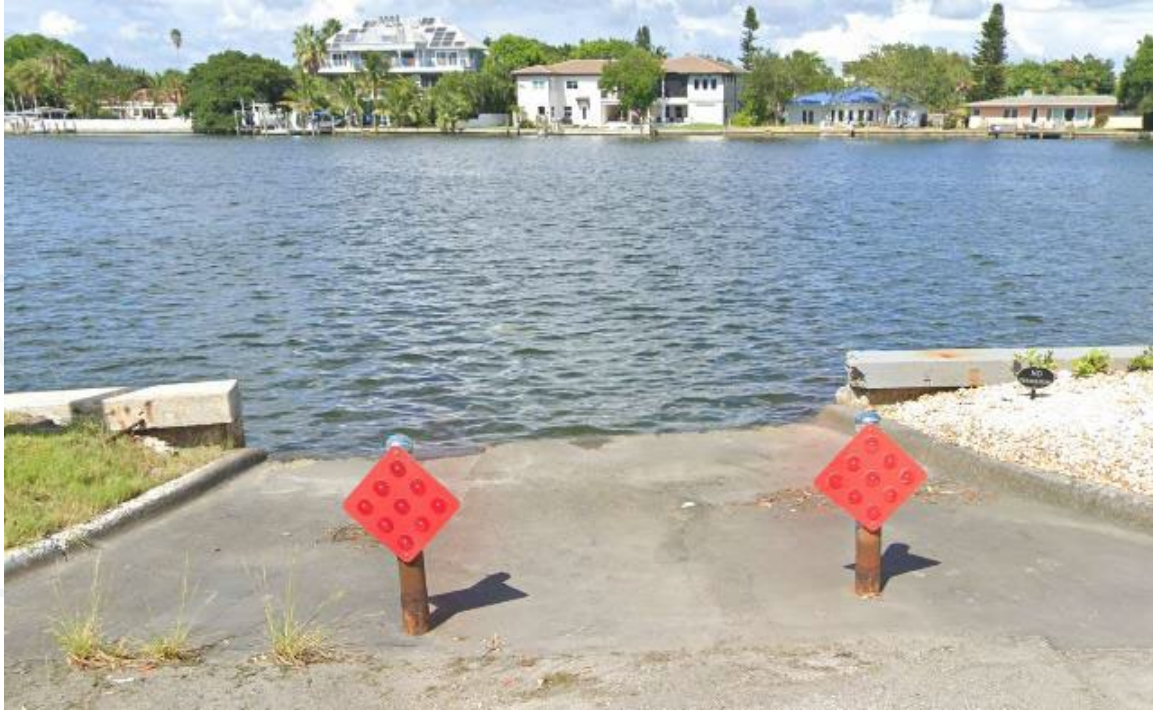
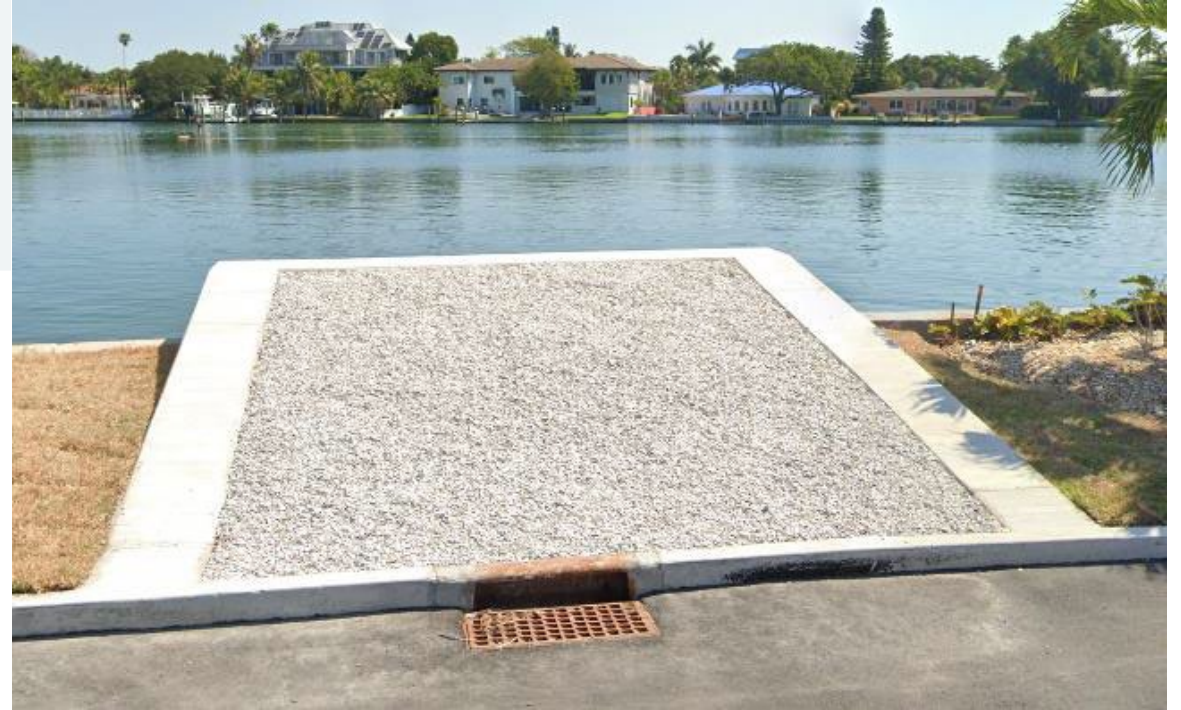
# Before and After

3612 E Maritana Dr

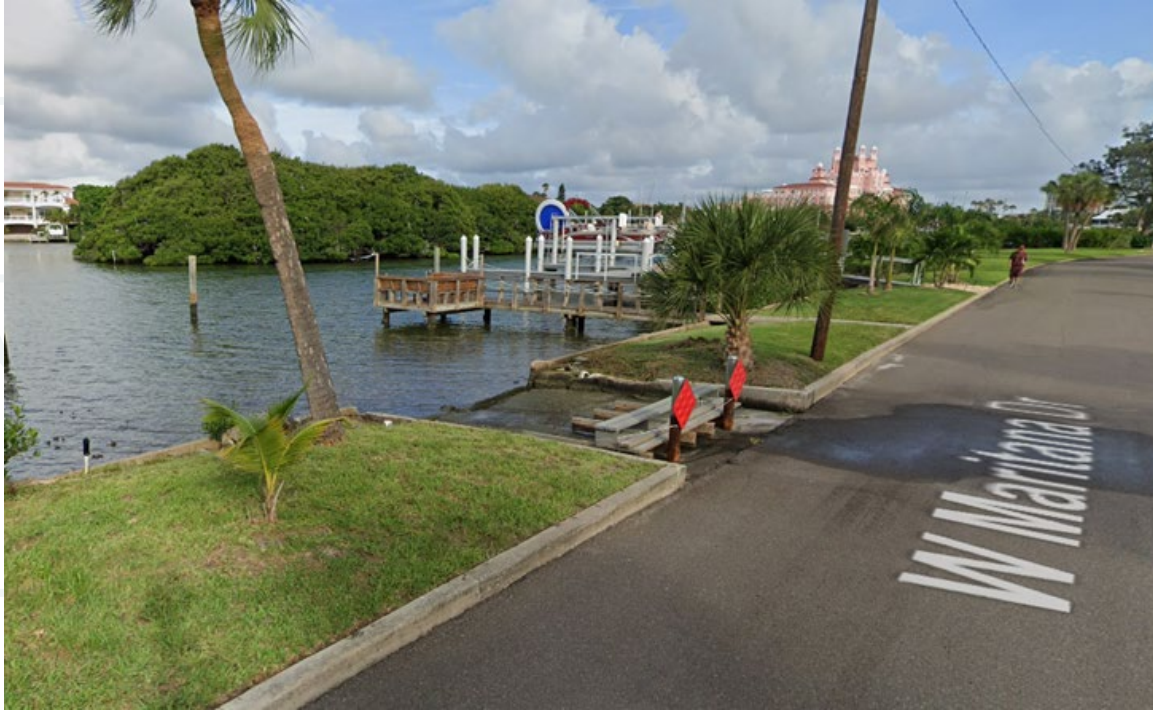
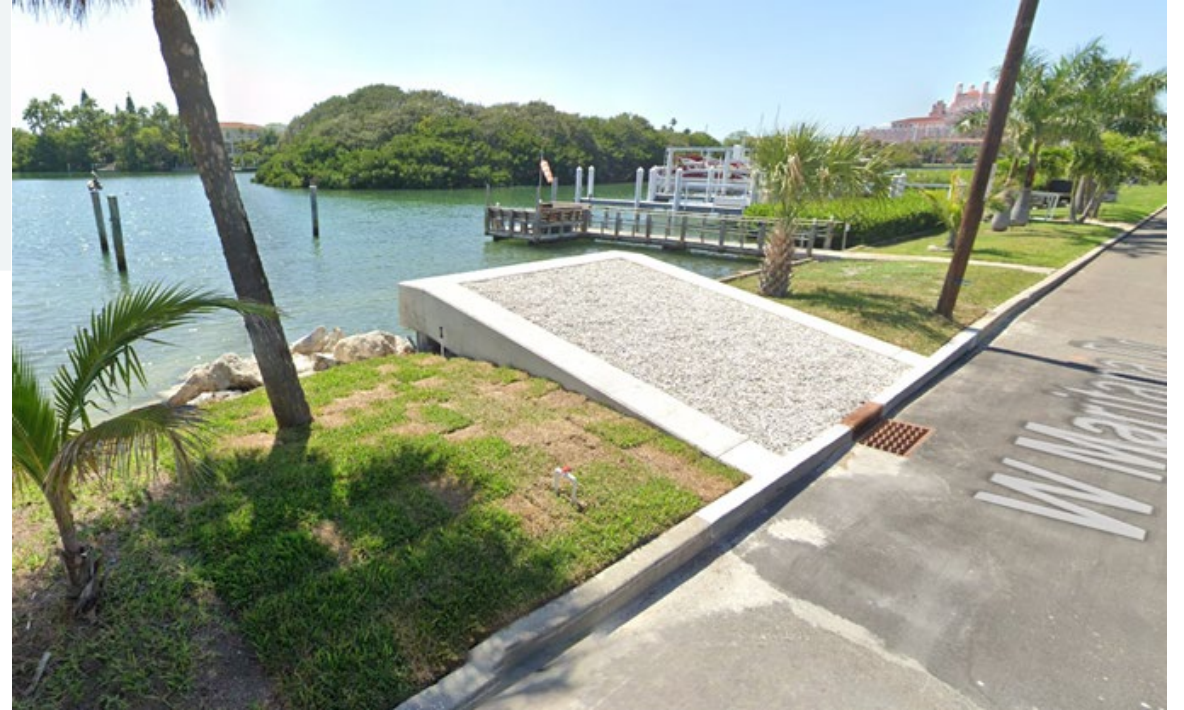
# Before and After

3107 W Maritana Dr
